## CAT C7 FAN BEARING REPLACED WITH GREASE-ABLE BEARING

### BACKGROUND:

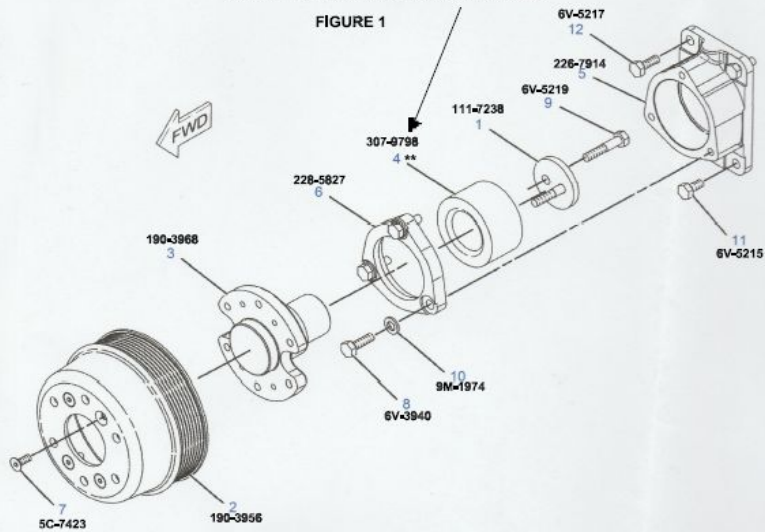
FIGURE 1

In 2006, I traded the Bus for a new Tiffin 2006 Phaeton with a CAT C7. The fan hub bearing is a sealed without a grease zerk. A friend has CAT C7 in his 2007 Phaeton. In Feb 2017 the fan bearing hub came apart at 72000 miles on I-20 west of Odessa, TX. Bottom line \$2700 later a sealed fan bearing was replaced by Freightliner in Odessa. In order to replace the bearing, Freightliner cut a hole in the fan shroud to access the bearing. After searching the internet I found that hub bearing failures have been occurring on motor homes that have the CAT C7. Since my coach has 62000 miles, the CAT C7 may be headed for the same problem. The reason that CAT used the sealed bearing was there was no easy way to grease a hub bearing. Under the existing CAT C7 configuration in a Phaeton it would be almost impossible to grease a hub bearing.

**FIGURE 1: CAT C7 WITH EXISTING SEALED BEARING.** This figure shows the existing configuration with a seal bearing.

\*\* SEALED BEARING PRONE TO FAILURE

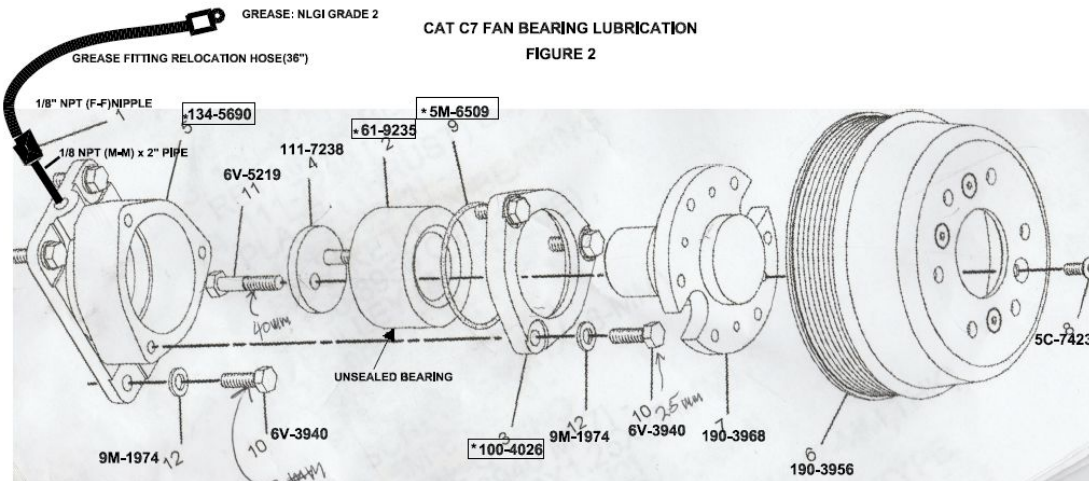
FIGURE 2

**FIGURE 2: CAT C7 FAN BEARING LUBRICATION.** This configuration shows a grease-able fan hub bearing via a 3' grease fitting relocation hose.

\*NOTE: THESE CAT PARTS REPLACE THE PARTS ON CURRENT C7 VERSION

**REPLACE HUB WITH ACCESSIBLE GREASEABLE BEARING:** Working with CAT HOLT in Fort Worth, we came up with a part substitutions configuration that provided an accessible grease-able hub bearing on my CAT C7. Several fan hub parts from the CAT 3126 engine are being incorporated in the CAT C7 fan hub. Table 1 shows the part comparison between the two engines. This configuration was installed in my 2006 Phaeton by CAT HOLT in Ft<sup>1</sup> Worth. The key to this installation is getting access to the fan and hub without removing the inter-cooler, radiator and hoses. Prior to the installed an access hole was cut into the top of the fan shroud which allowed access to the fan and hub. This was done ahead of time to save cost. See Figures

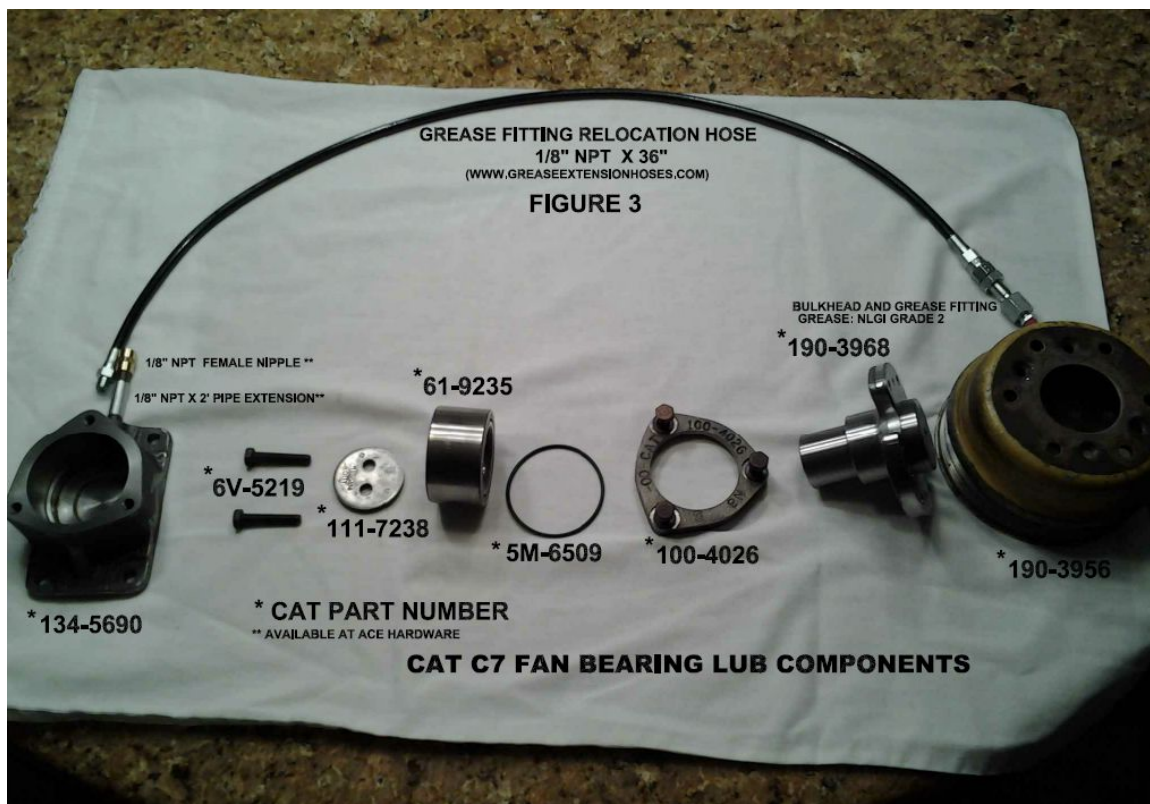
**FIGURE 3 CAT C7 PARTS LAYOUT:** Figure 3 depicts the parts layout . Note the 3" NPT 1/8" pipe extension. This extends the grease hose above the pulley. **Figure 4** depicts the routing of the grease fitting relocation hose. The hose should be tie wrapped to the shroud frame housing.

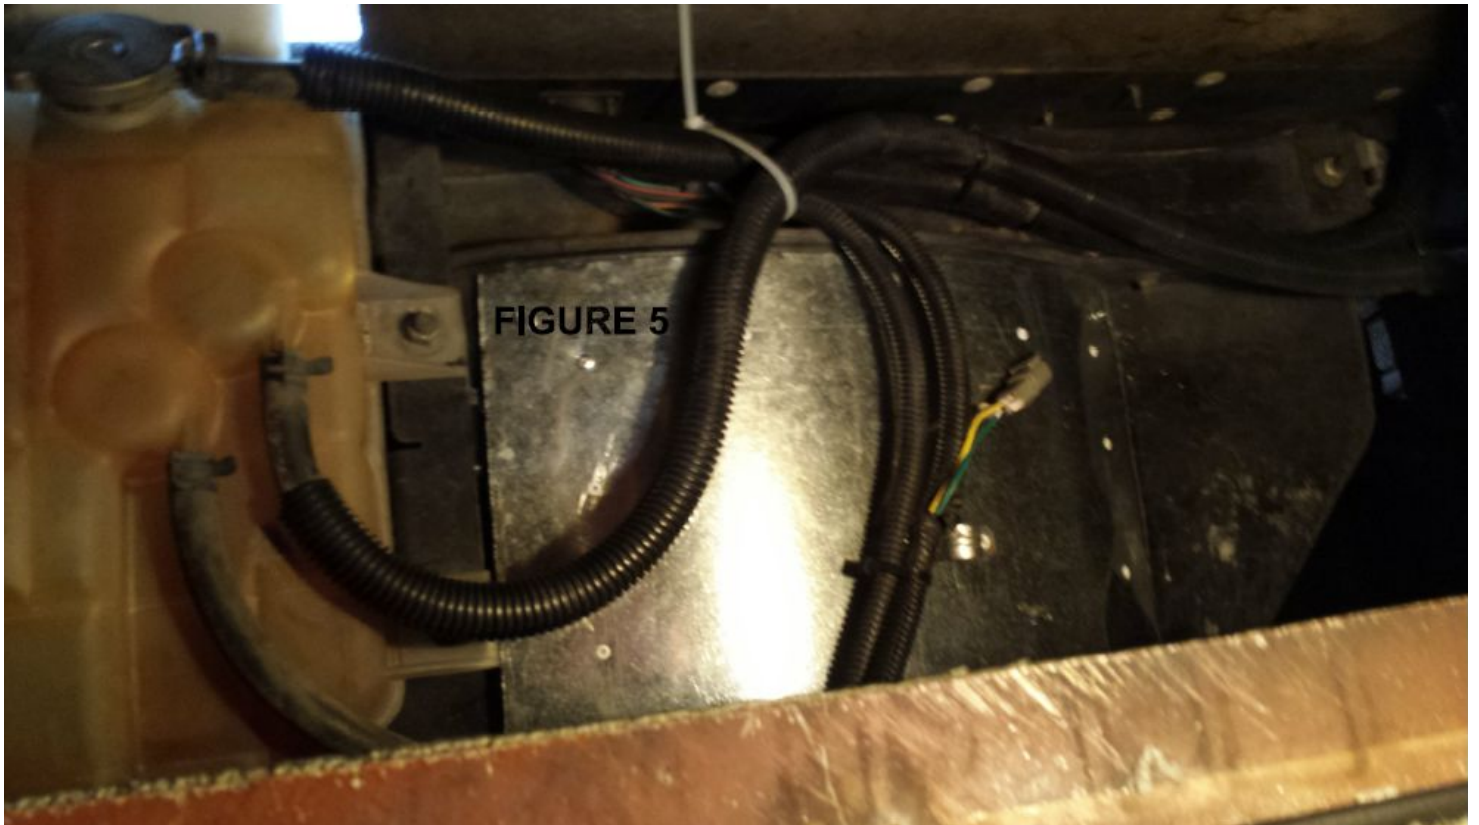
**FIGURE 5 ACCESS TO FAN:** **Figure 5** shows a metal cover over a cutout of the fan shroud that was made to access the fan and hub bearing. **Figure 6** shows the access to the fan. The fan was removed and moved forward to the inter-cooler. This allowed access to the fan belt and hub bearing. **Figure 7 and 8** shows the cover that was fabricated to cover the hole. The shroud is made of fiberglass and was cut out using an oscillating saw. The cover is made from the fiber glass cutout and sheet metal. The sheet metal is riveted to the fiber glass that was cut out. The cover is attached to the shroud by using six self tapping metal screws.
