**PROCEDURE FOR SERVICING
BASEMENT A/C UNITS ON WINNEBAGO PRODUCTS**

By

Bill Elsenpeter

July 8, 2008

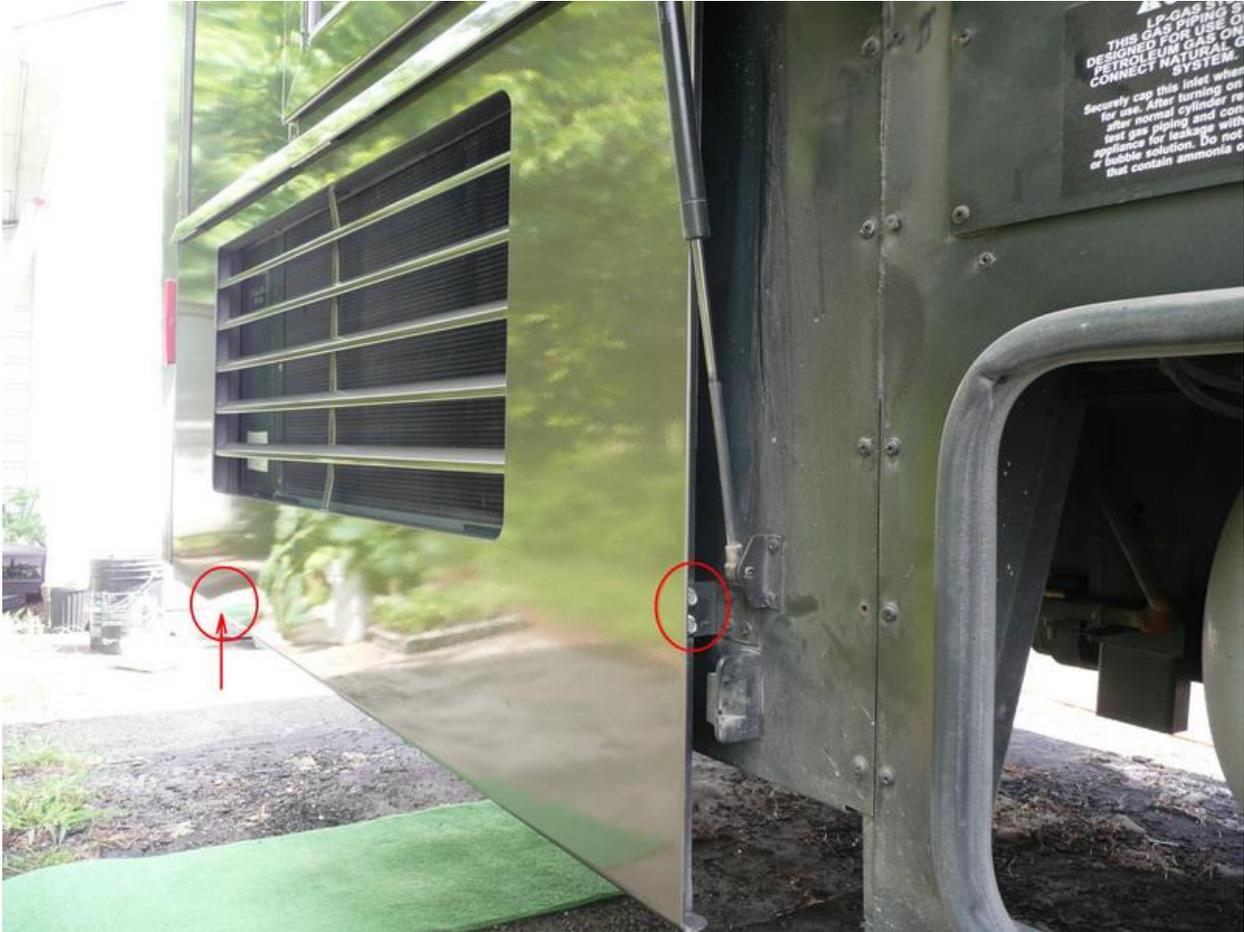
1. Remove 4 screws to open access door.

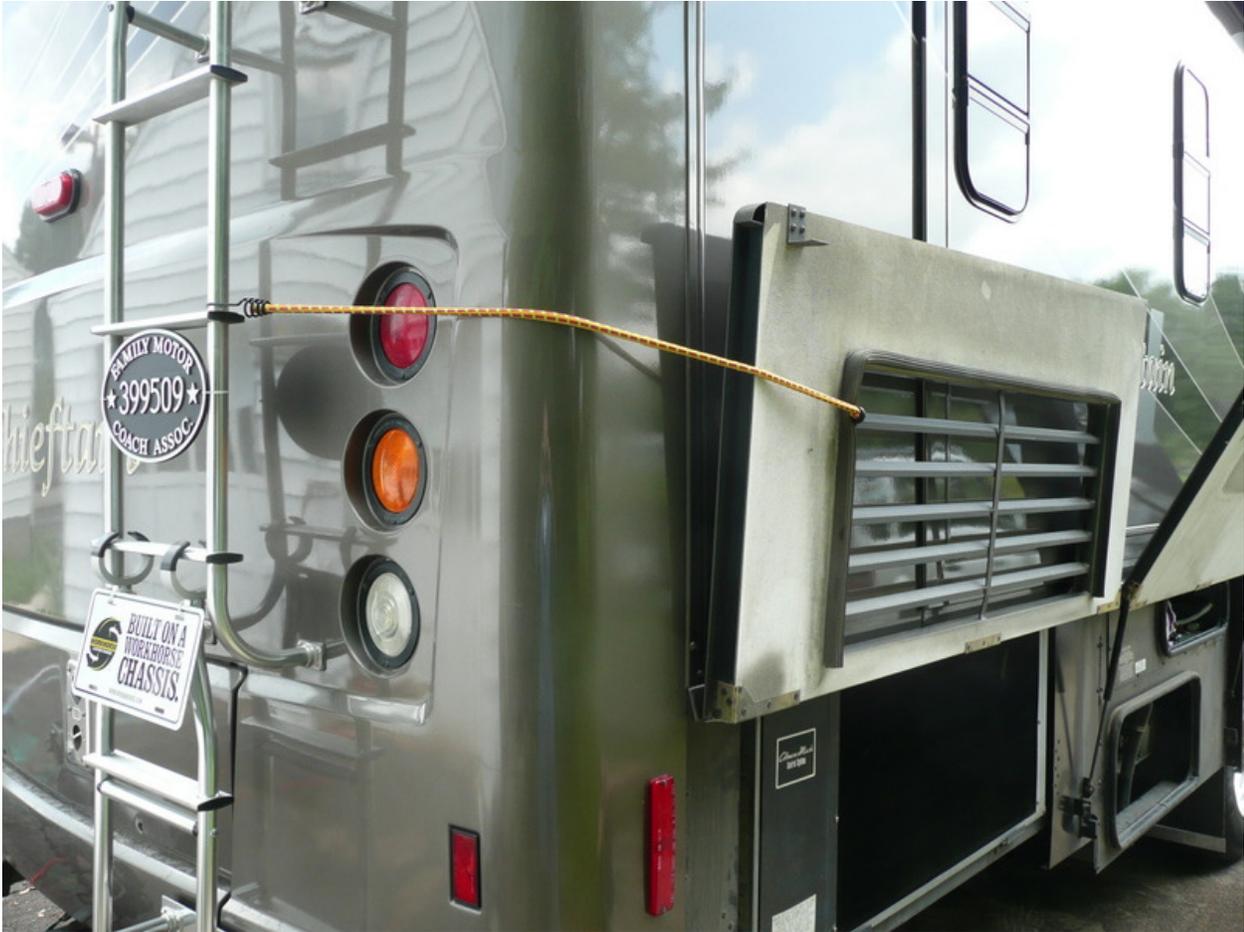
2. Use bungee cord to hold door all the way up.

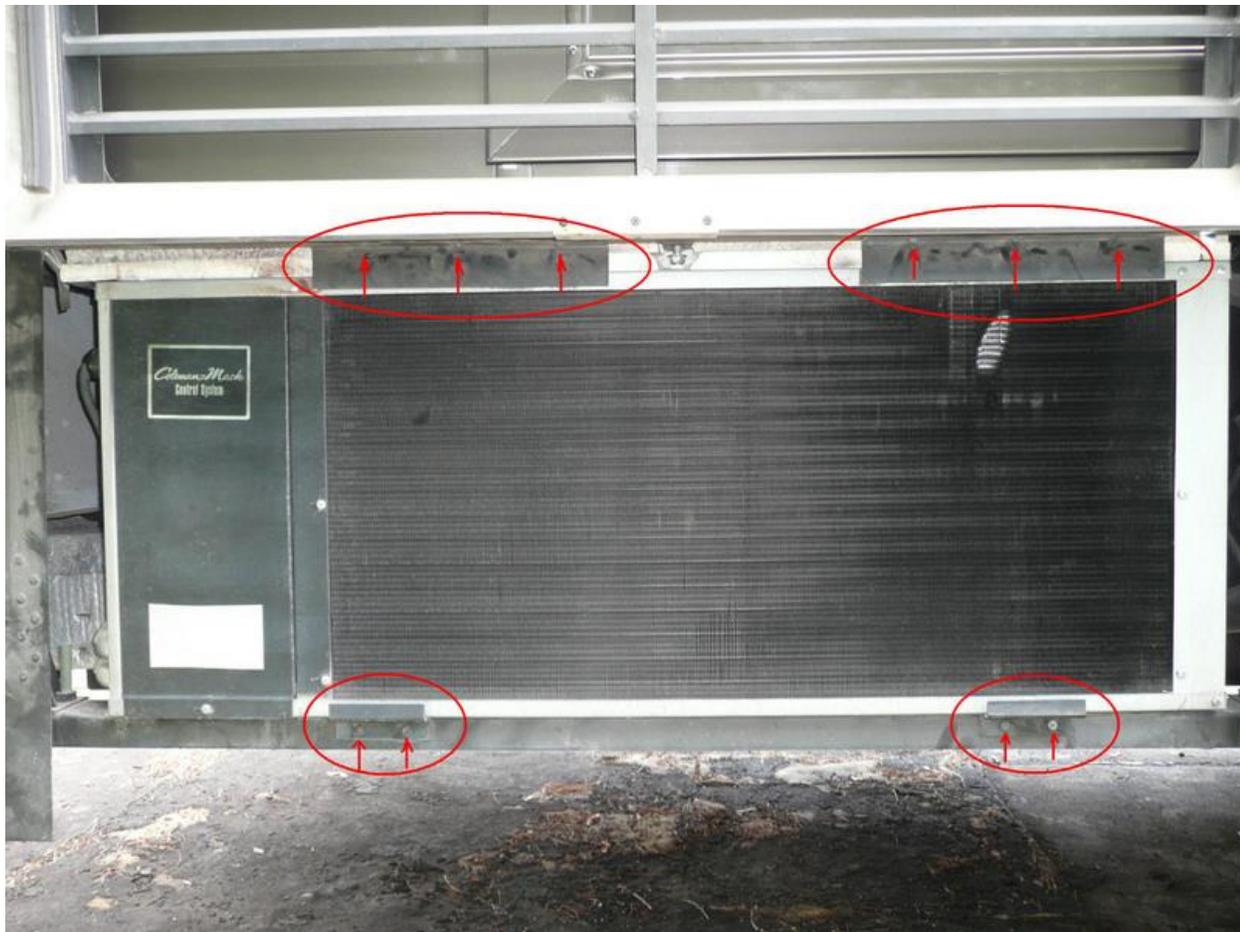
3. Remove 10 screws that hold the 4 retainer brackets.

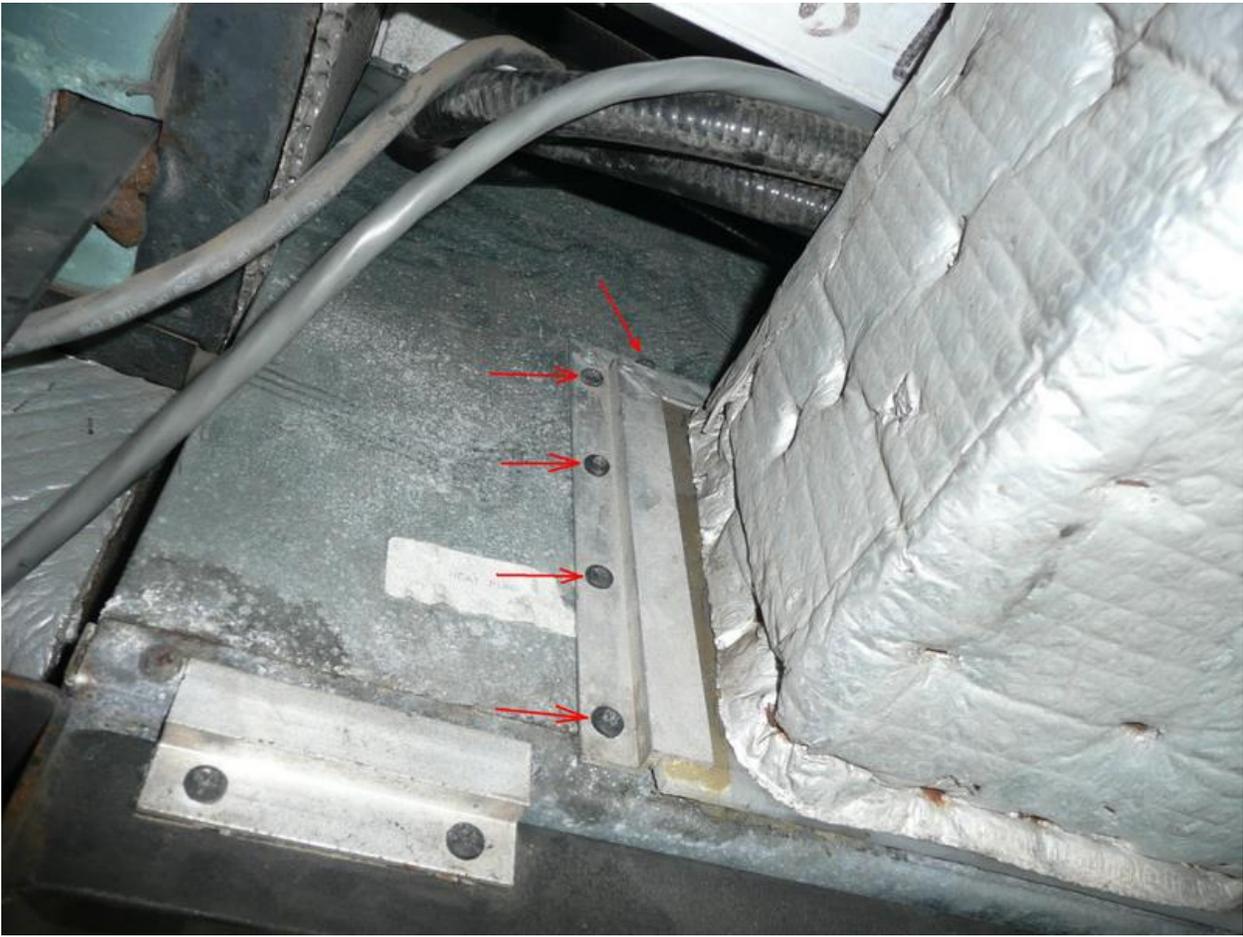
4. Remove 5 screws on left side of the cold air output duct. Good news is that there are no screws across the top!

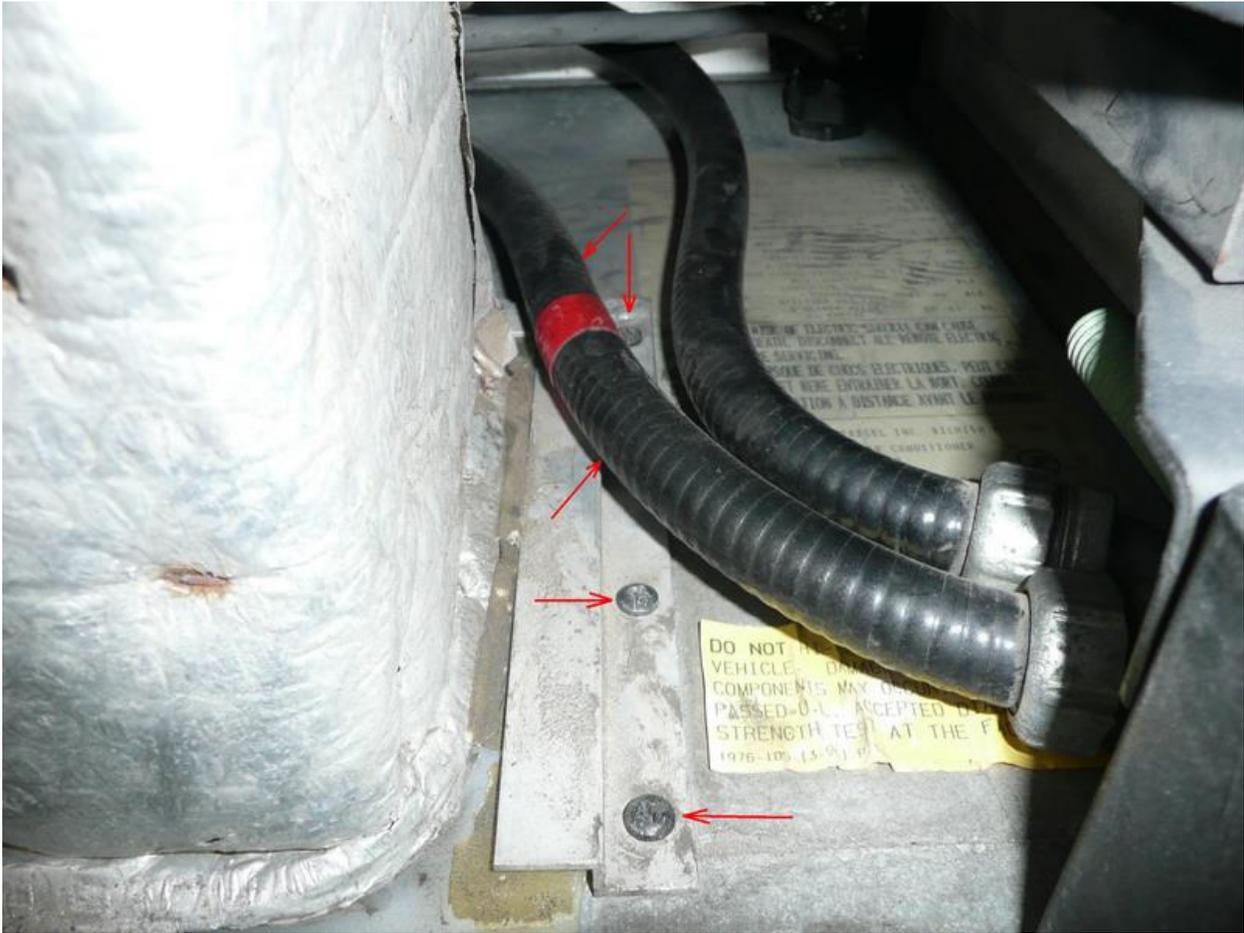
5. Remove the 5 screws on the right side of duct. A short 6" screw driver is useful on the top 3 screws. Have a helper hold the power cables back out of the way to aid access to screws.

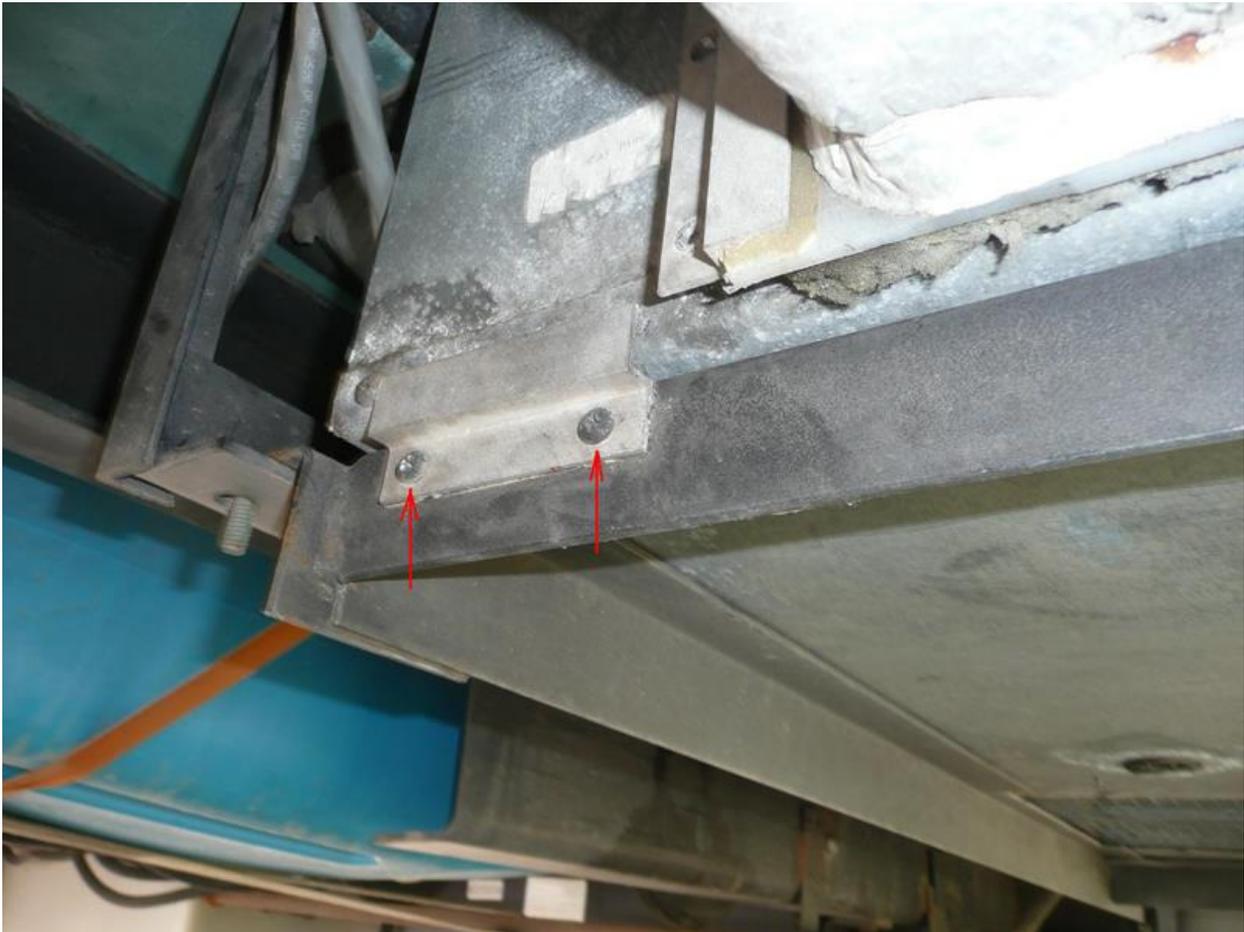
6. Remove (or loosen) the 2 screws if it is possible (if not too corroded). These sheet metal screws are going into heavy angle iron and can be difficult to remove. It may be possible to remove A/C unit without messing with this bracket. I was able to back out 3/8 inch & that allowed plenty of clearance.

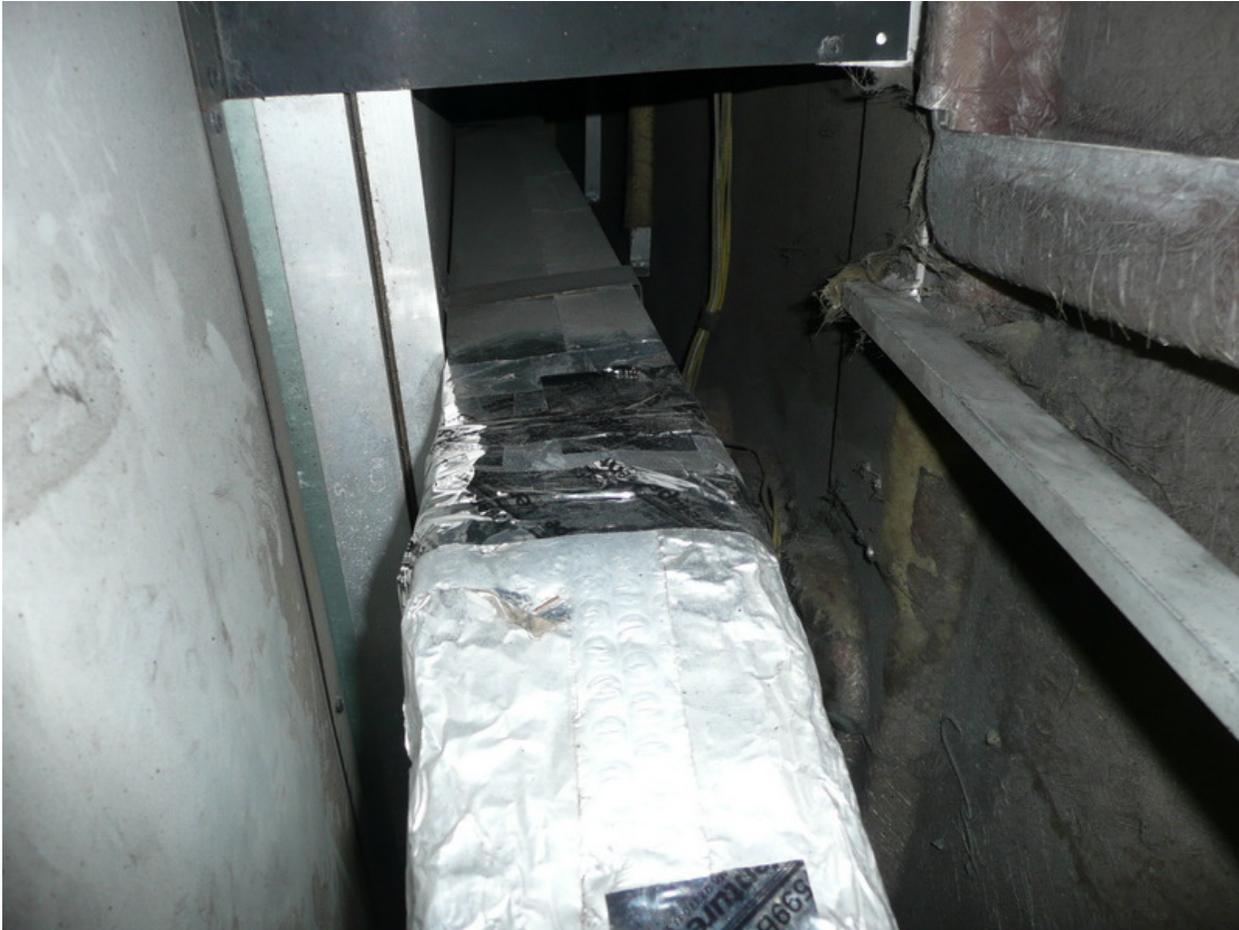
7. Check the seal of the aluminum tape about 1.5 foot up the duct work. In my case the whole 90 deg elbow fell to the ground because the alum tape adhesive had dried out. I had to cut about 3 in of alum tape off and re-taped with "Venture Tape". Venture Tape is very expensive (\$35/roll), but it is designed to hold duct joints permanently in very hot/cold attics.

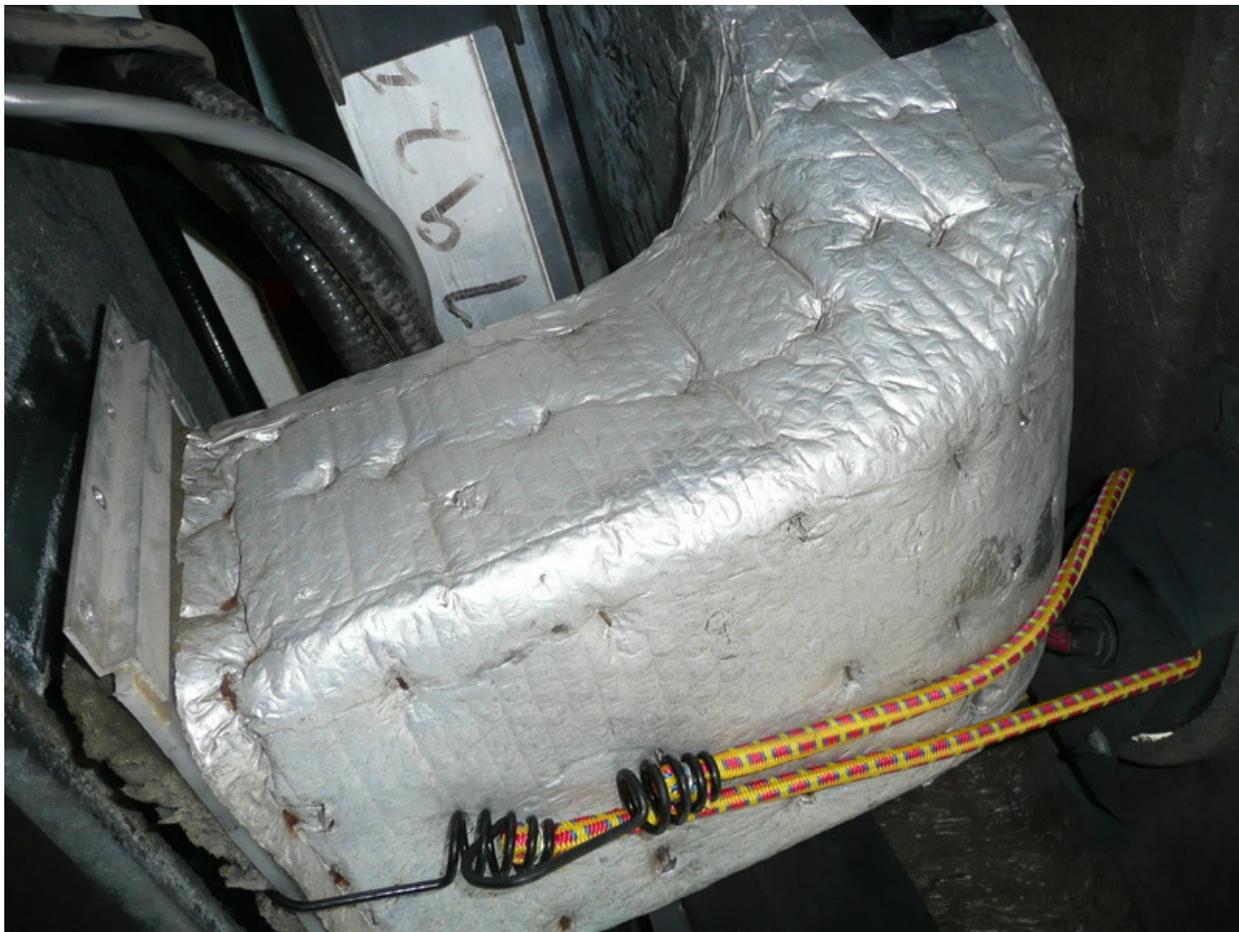
8. Use a bungee cord to hold duct back about an inch so the foam seal is not torn off.

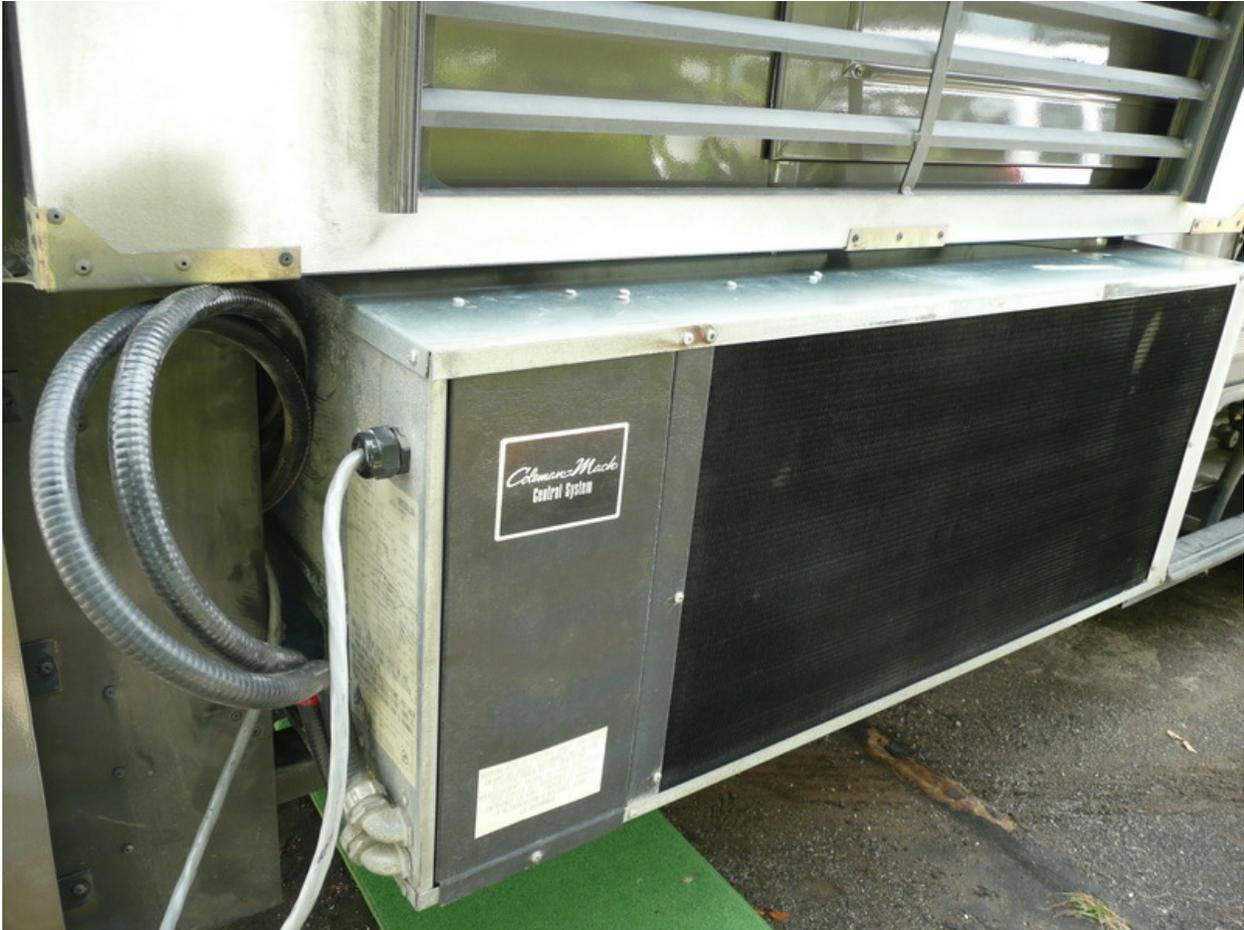
9. To push the unit out, I got on the green carpet under the unit. On my back I used my feet to slide the unit out about 1-2 inches, and then slightly raise the unit and slide out about 6 to 8 inches. There are several screws sticking out the bottom about 1/4 in and these hit and drag over the bottom supporting brace. Once the unit is out this far, then pull the power and control cables out so they will not get caught on the duct work.

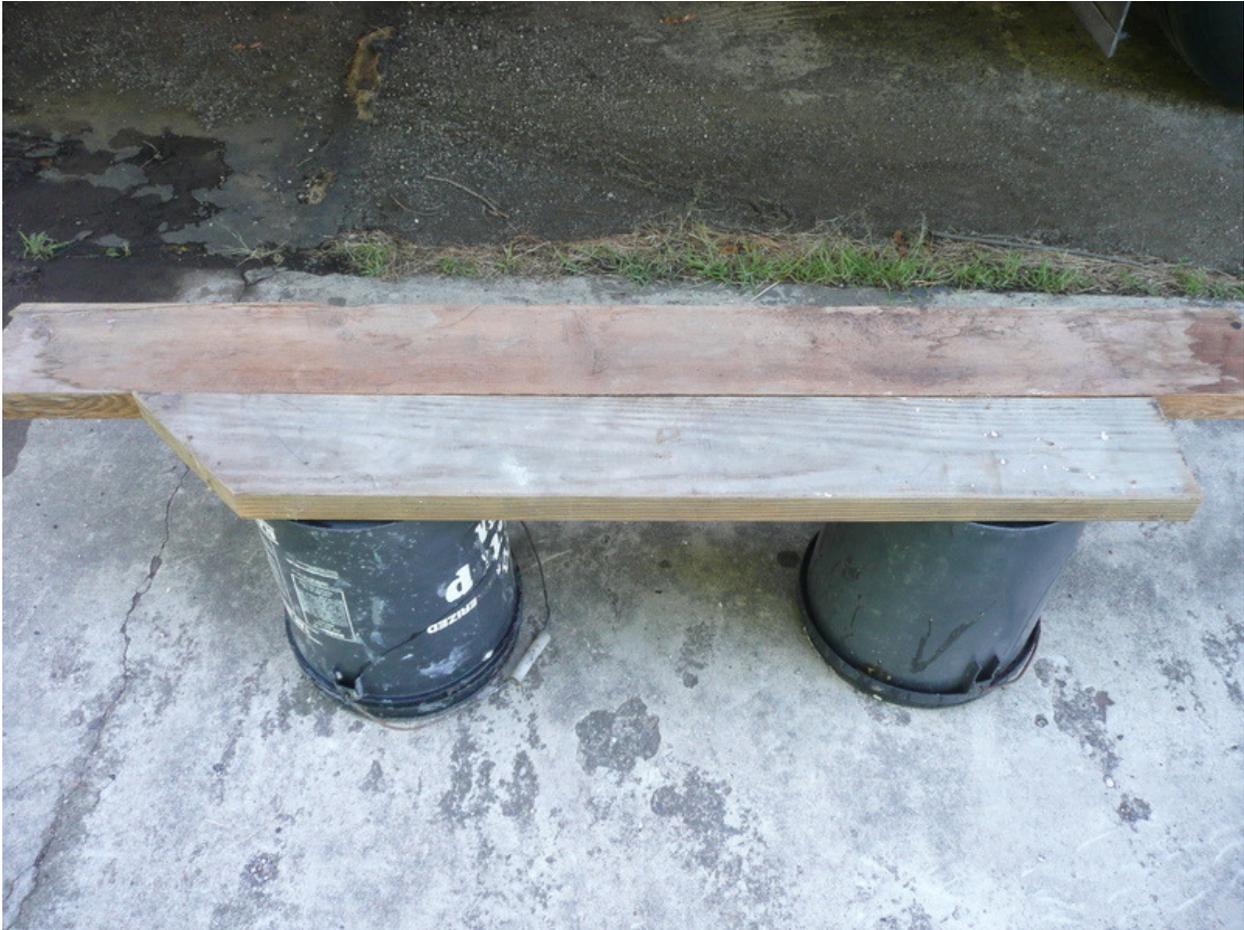
10. Support the unit off the ground to make it easy to carry, work on, and test while still keeping all the cables connected. I built a bench from two 5 gal buckets and two 2x6 planks. This was plenty strong and stable. Earlier in the campground I used the bench part of a picnic table. Leave open space under the Outdoor Blower screen so you can run the unit with the top panel off and test everything before closing up.

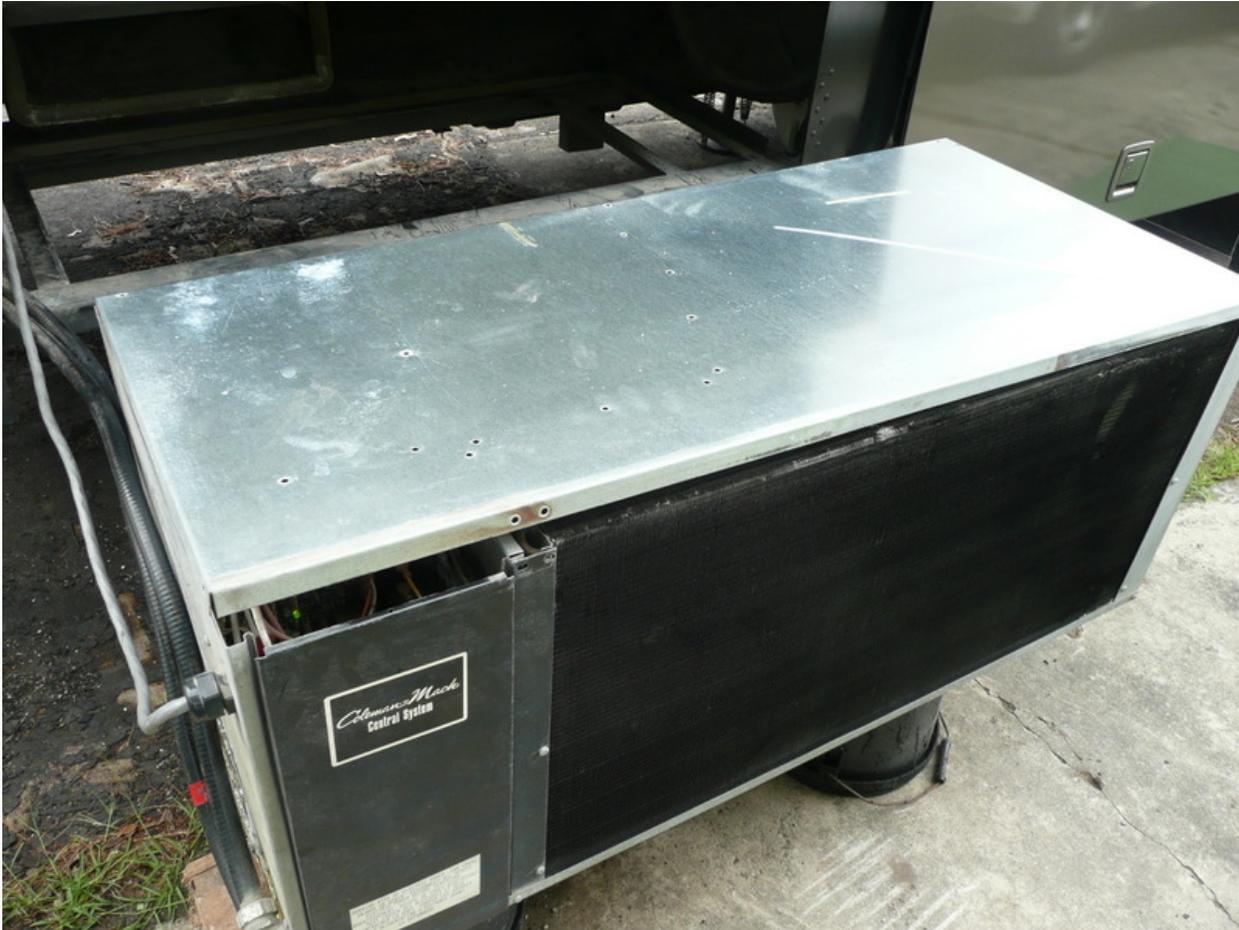
11. Use two people to pull the unit out and sit on support bench. The left side has a nice hand hold using the cold air duct opening. The right side has the two compressors and is somewhat heavier so the stronger guy should take that end. I'm no weight lifter and didn't have any problem getting the unit in/out two times with no muscle or back strain. Once you start pulling it out the two top styrofoam pieces will drop down.

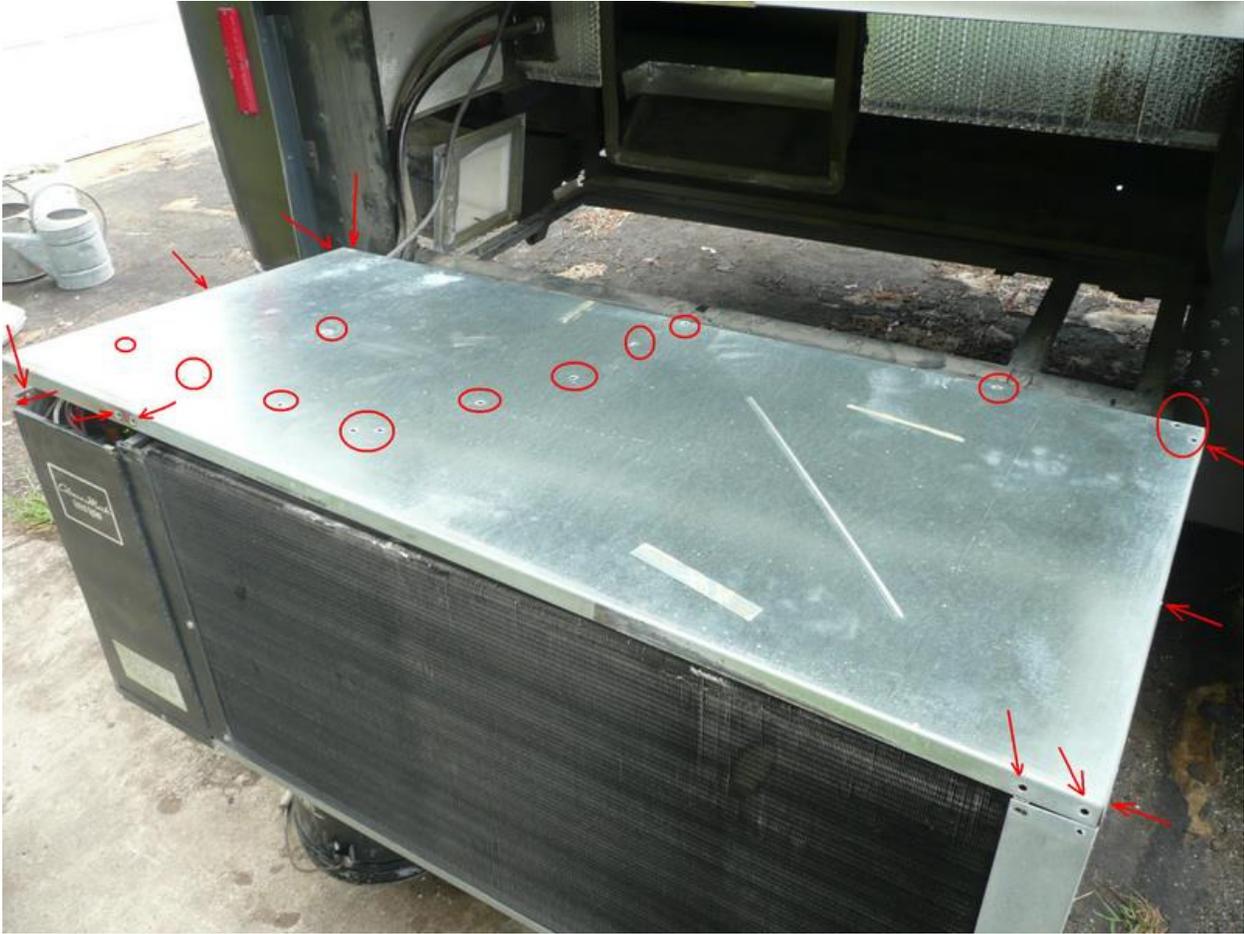
12. Take off the top cover by removing the approx 28 screws.

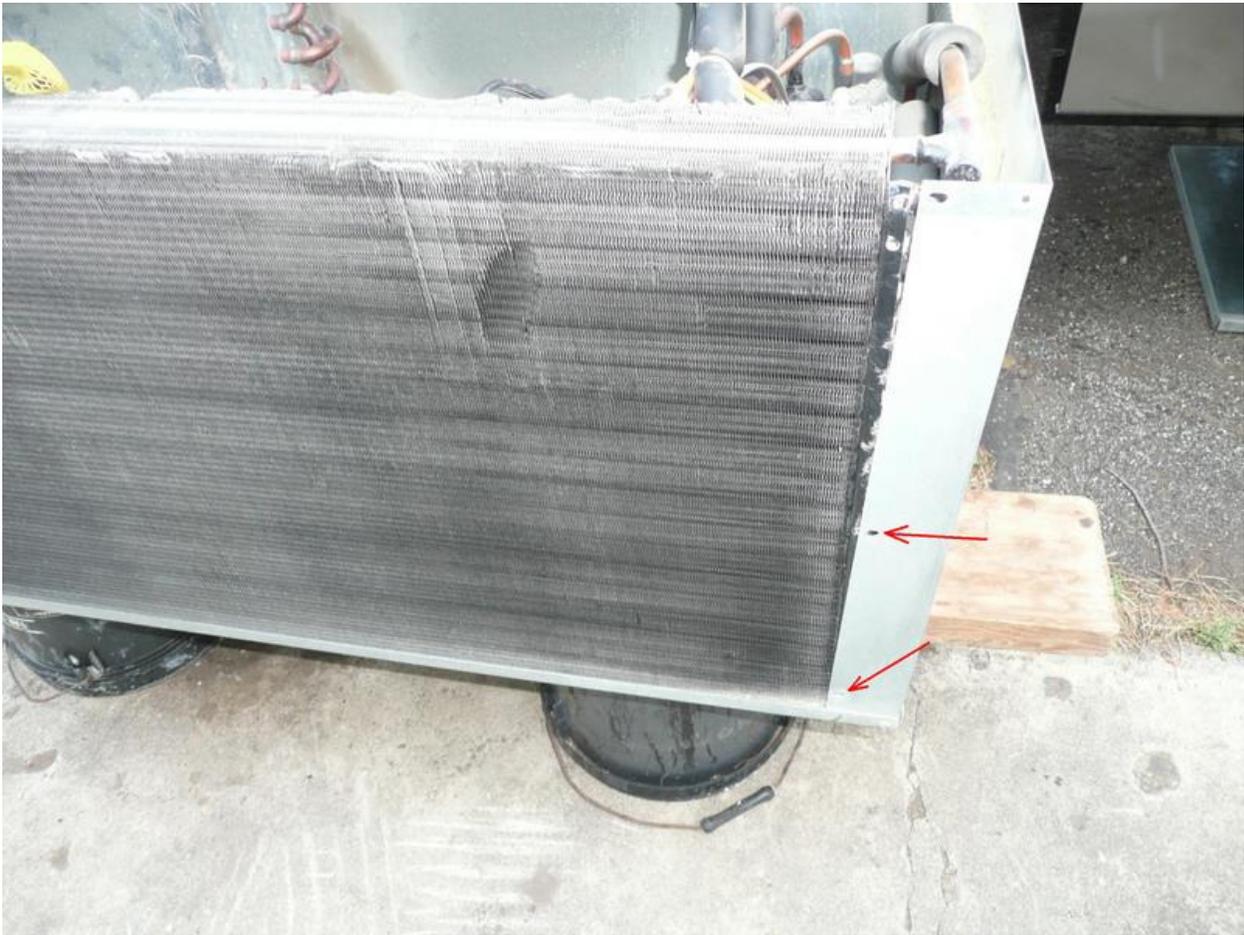
13. Remove these two additional screws to allow the condenser coil to be opened at the top if you need to pull the outdoor blower assy.

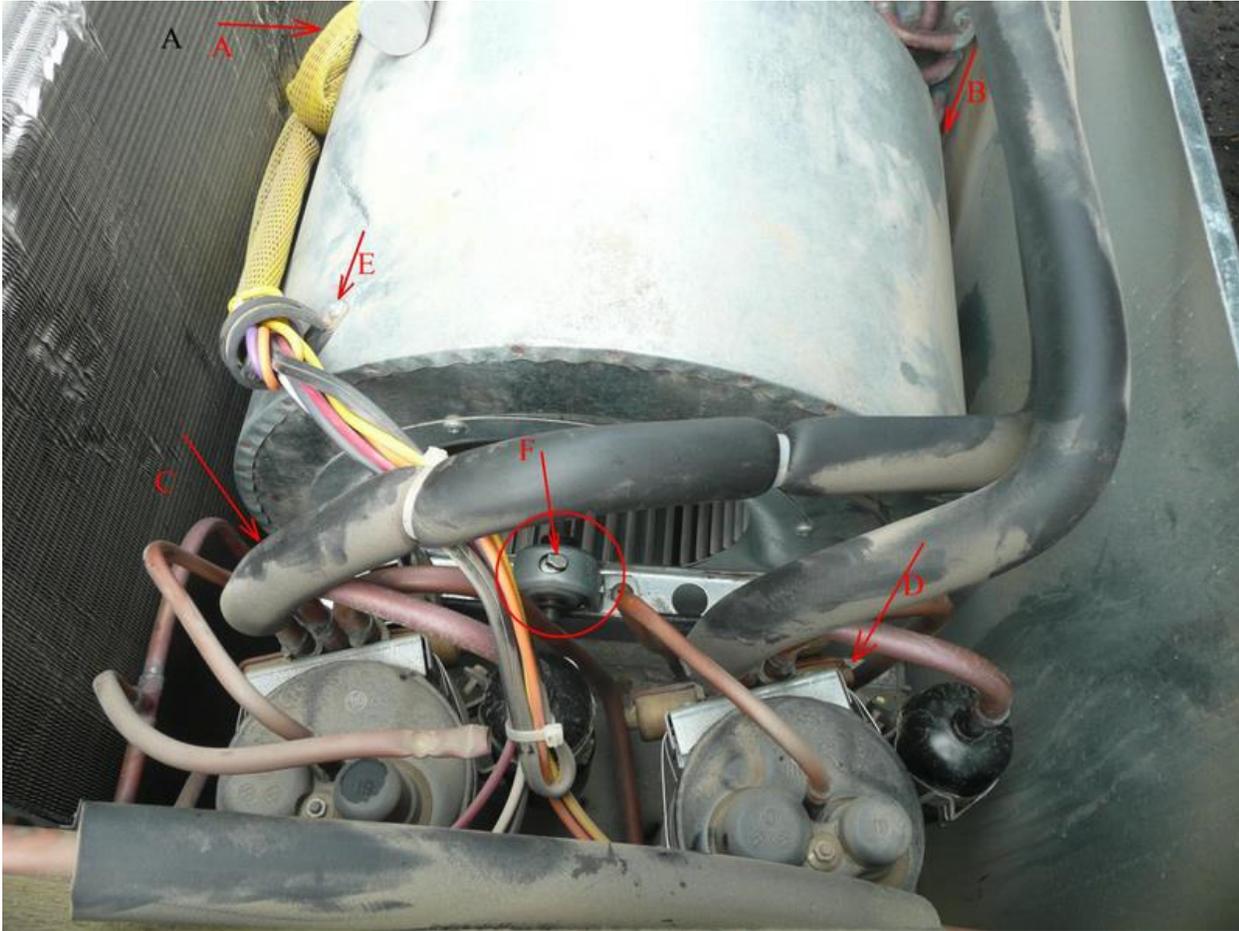
14. View of outdoor blower assy and location of brass bearing lubrication point (F). RVP service calls for 2 drops of 30 wt oil once a year for a/c units mounted on the roof. In the Operator Manual for the basement units it does not call for annual lubing but this is probably going to fail if not lubed regularly. If blower motor or squirrel cage needs to be replaced, remove 1/4 in hex nuts located at bottom A, B, C & D using ratchet and 7/16th socket and long extension(s). About 12-14 in extension is required. Remove cable clamp (E).

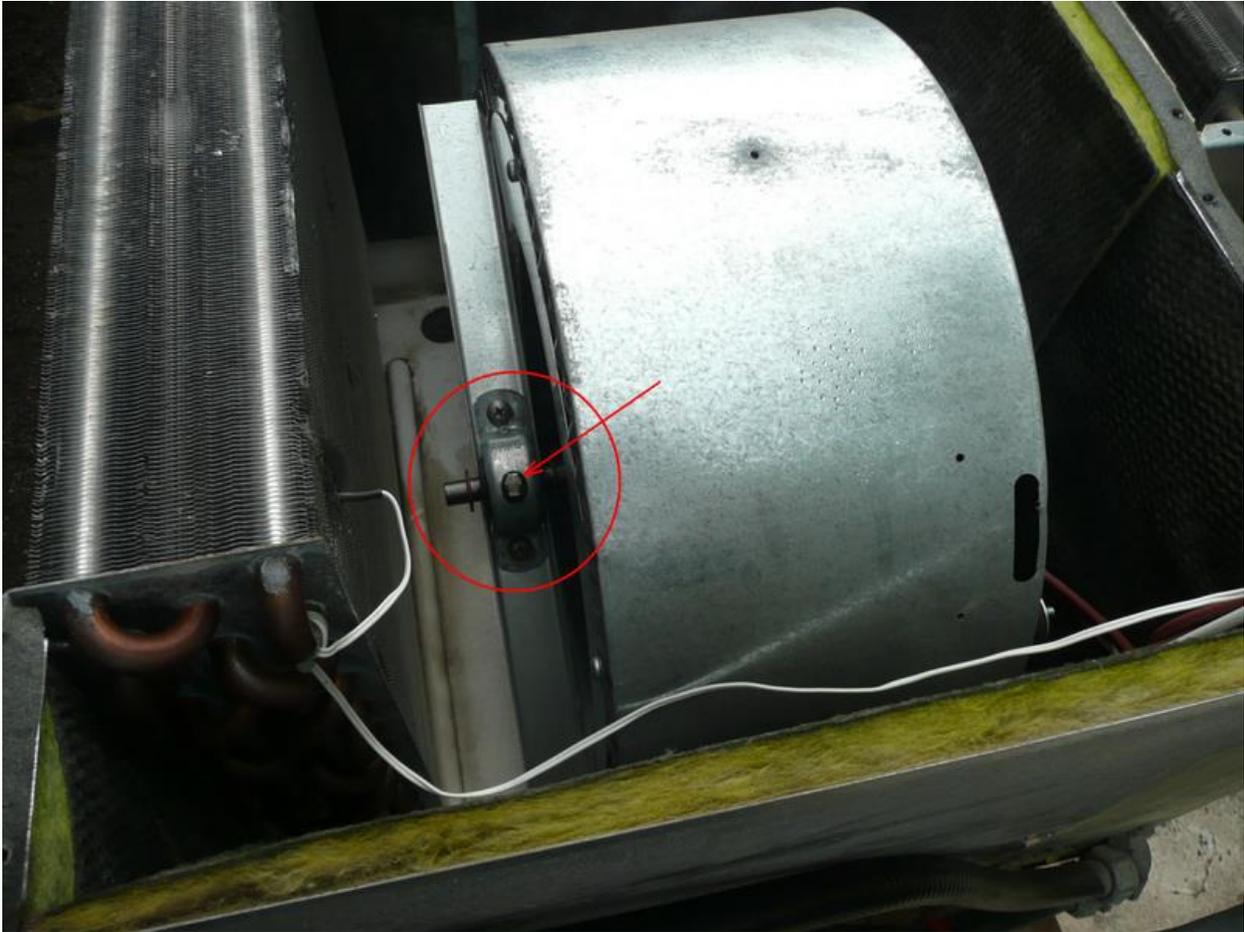
15. Lubrication point of the brass bearing of the indoor blower assy.

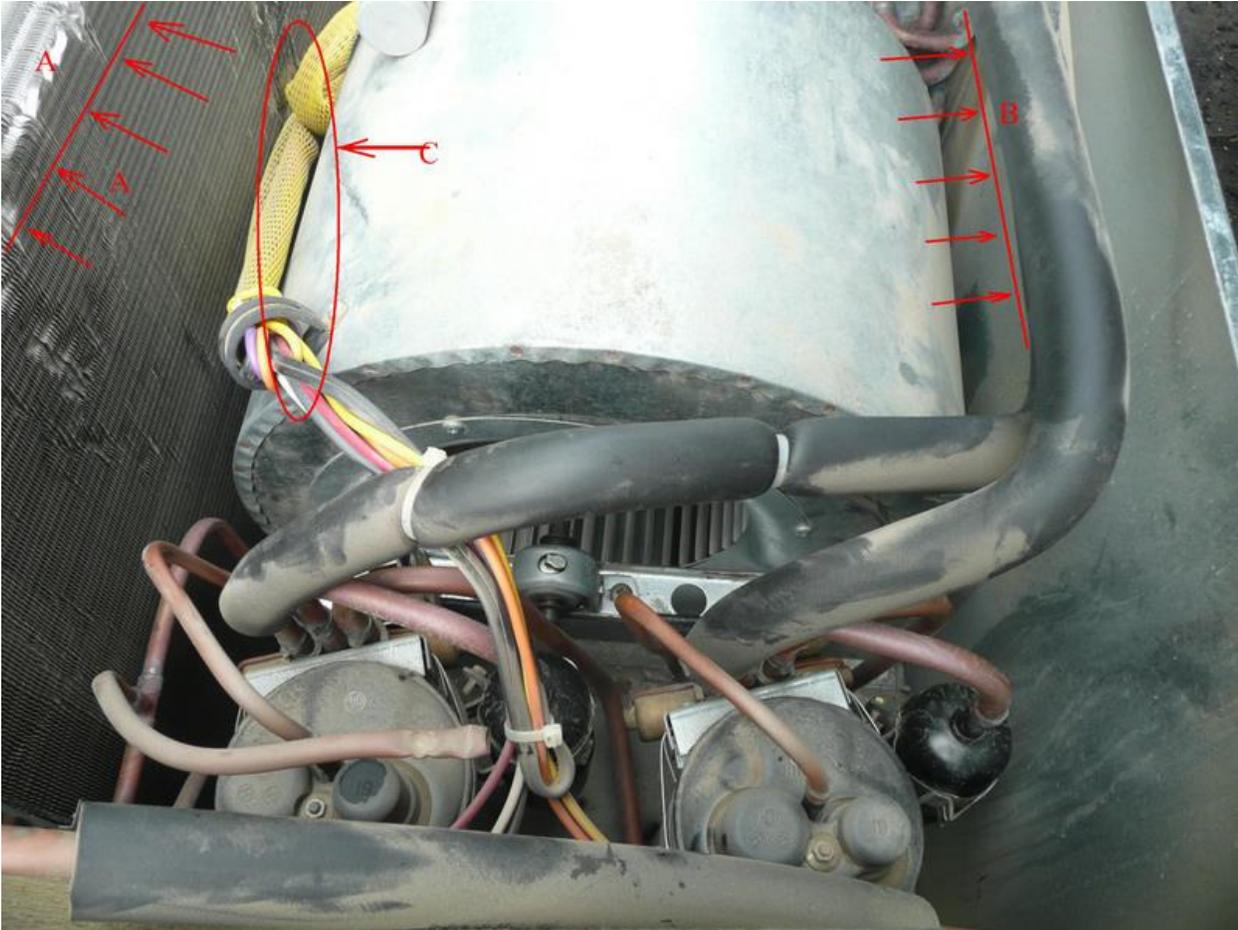
16. To remove the blower assy, pull the cable bundle up and out over the coils on the left. Have a helper hold the coil out at the top about 1 in (A) and push against the rubber covered copper line to provide a little more clearance so as to NOT touch and damage the coil fins on the left. Once pulled up to clear the 4 studs, the blower assy can be rotated and lifted out. It is a tight fit so take your time and don't bang up the delicate alum fins.

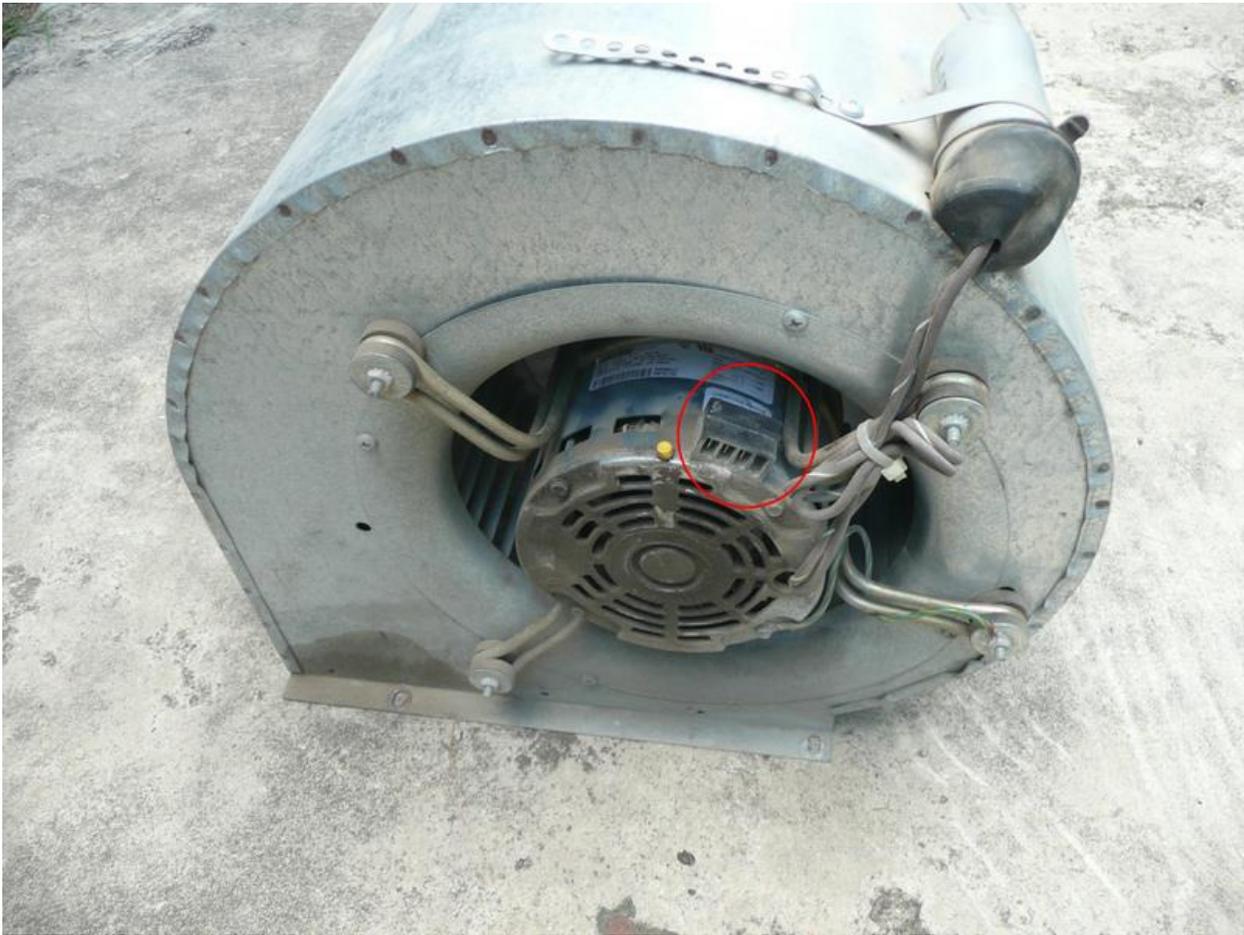
17. Remove the three power wires at this connector. The connector is labeled Common (White), Hi (Black), and Lo (Red).

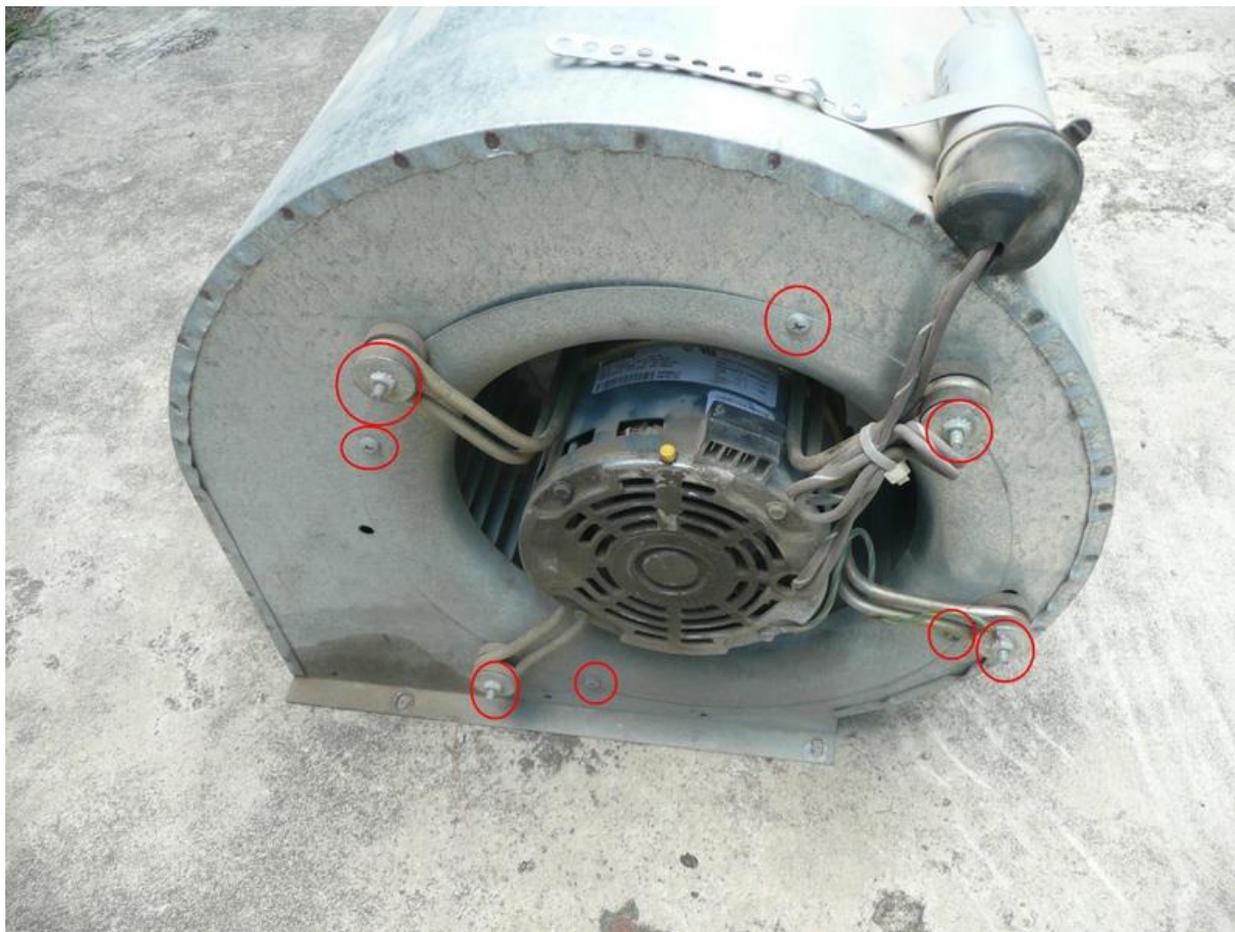
18. To replace the motor and/or squirrel cage, remove the 4 ea screw & nuts. Disconnect the two brown wires from the starting cap. Note the brown/white connects to the bottom spade lug (behind the rubber cover). Also note the motor bracket is not symmetrical & when re-assembling, make sure the wire connector is at the top.
