**PROCEDURE FOR SERVICING
BASEMENT A/C UNITS ON WINNEBAGO PRODUCTS**

By

Bill Elsenpeter

July 8, 2008

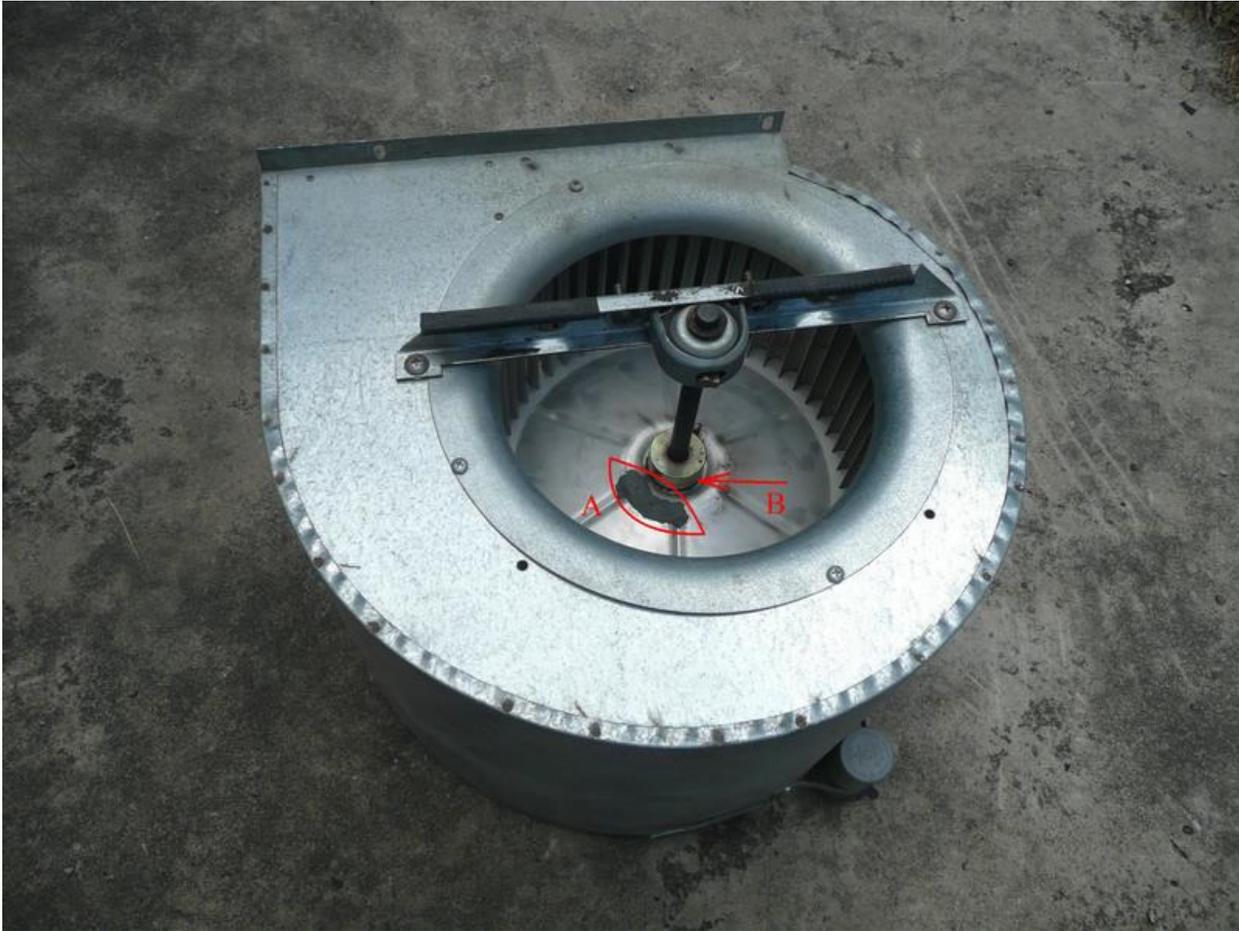
19. View of the epoxy I put over the 2" crack (A) in the alum hub as a temporary fix. In my case I was getting a rattling sound which was caused by a loose press fit between the steel hub and the alum wheel at point B. When re-assembling, note that centering the motor, the shaft just sticks out about 1/4 in from bearing. The new squirrel cage is centered in the blower assy. Torque the allen screw very tight. It has Loctite pre-applied. Reconnect the ground wire and the brown starting capacitor wires. The brown/white wire connects to the inside spade terminal on the cap.

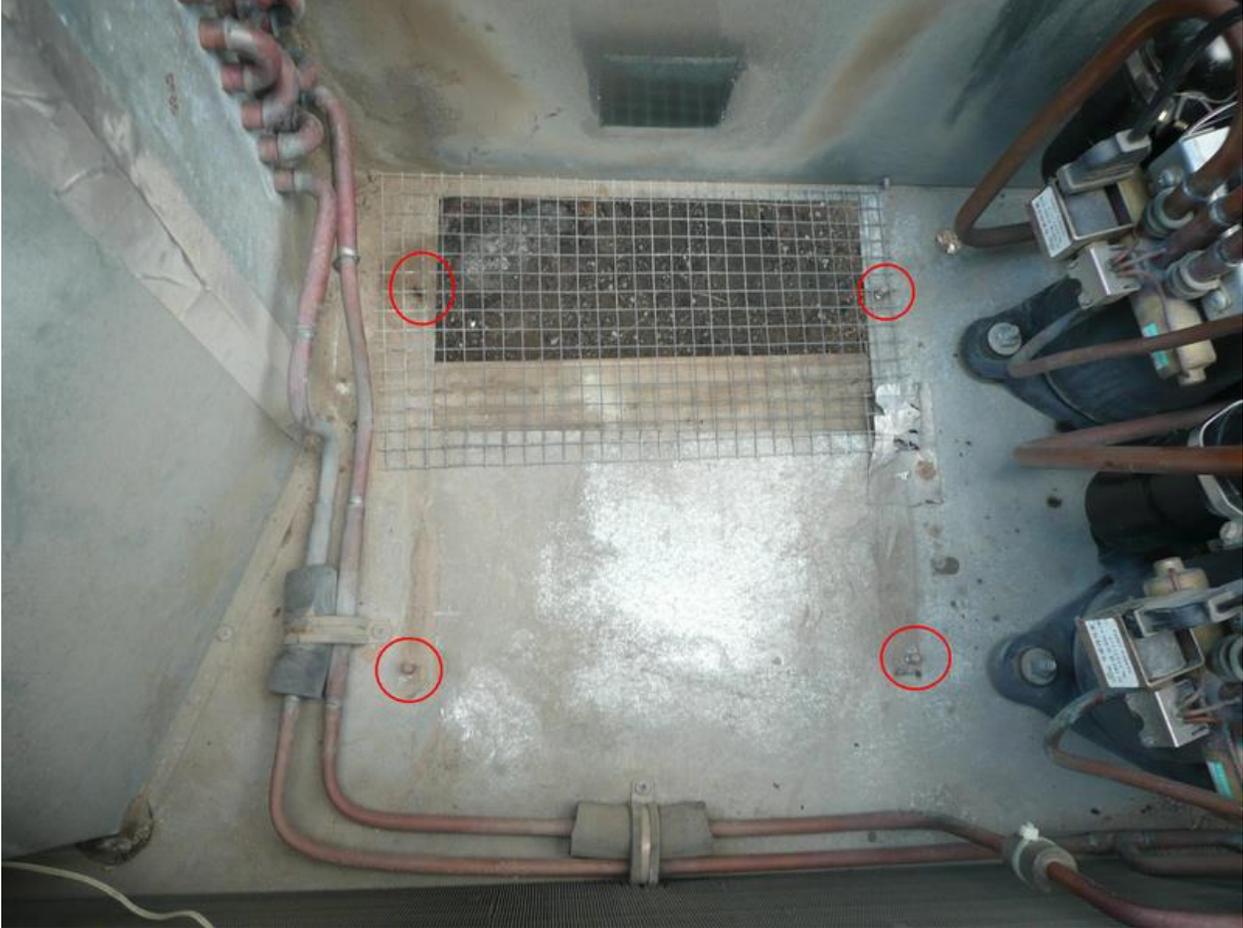
20. Clean the 4 studs and suggest coating with anti-seize since a lot of moisture will accumulate, especially upper left where the ends of the evaporator coils are exposed and drip condensate. Clean out the plastic tray and rubber drain hole under the indoor coil just to be left in this picture. Use a vacuum cleaner and a brush attachment to clean the intake side of the indoor coil. Mine was quite clean but it would depend on fit, type, and maintenance of air filter used. The outdoor coil is easy to clean anytime.

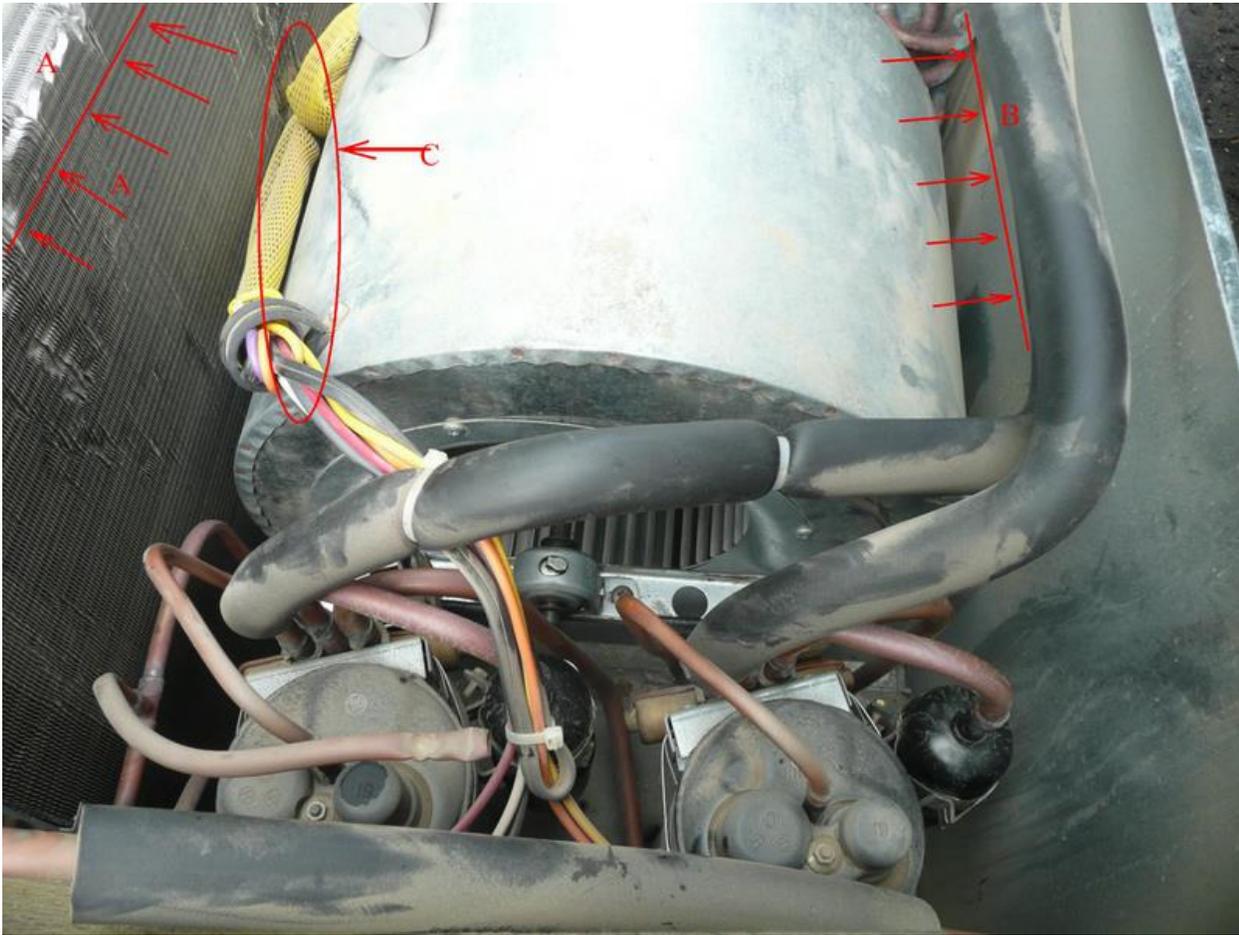
21. Use reverse procedure to re-install the blower assy. Use a little sticky butyl rubber on the nut to hold in the 7/16 socket to get the nuts started.

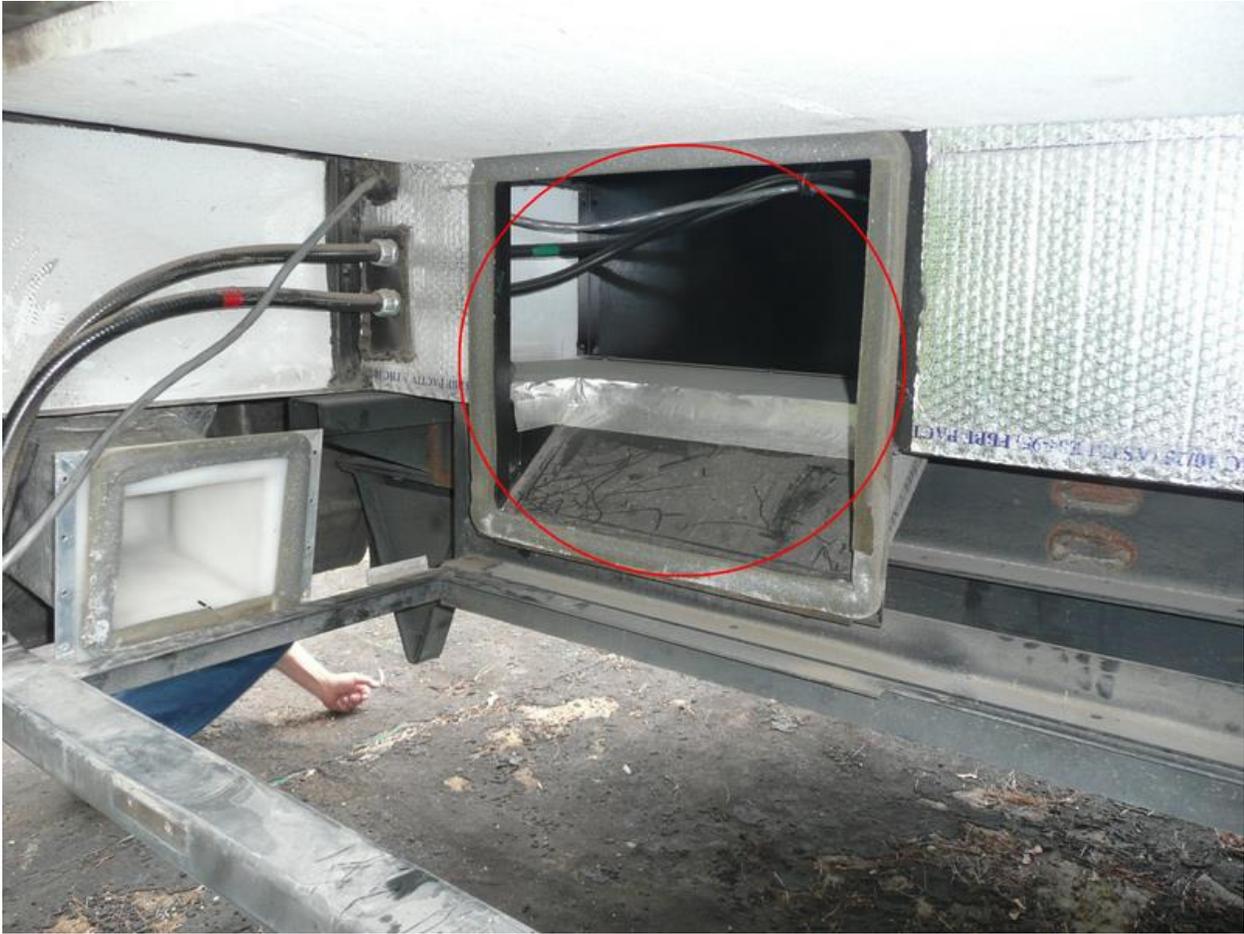
22. Clean out dirt & construction debris in the intake & output duct work.

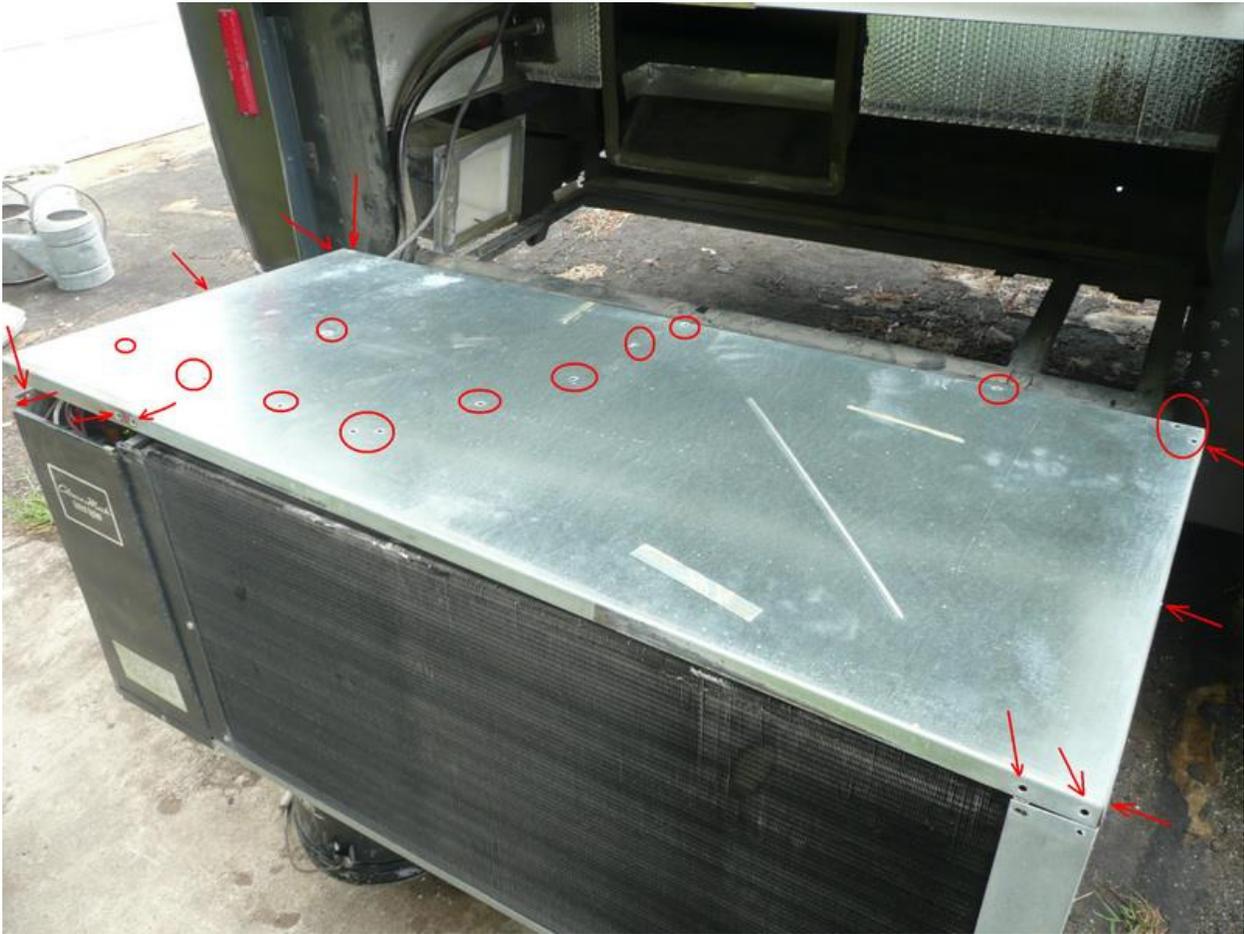
23. Reinstall the top cover using the approx 28 screws. Use a pointy object like an awl to align some of the holes in the middle of the top panel. Put the two screws back in front of the right side panel. Slide the entire unit back in coach. Once the unit is partially in, then feed the power cables up and over the duct. Re-install the four brackets.

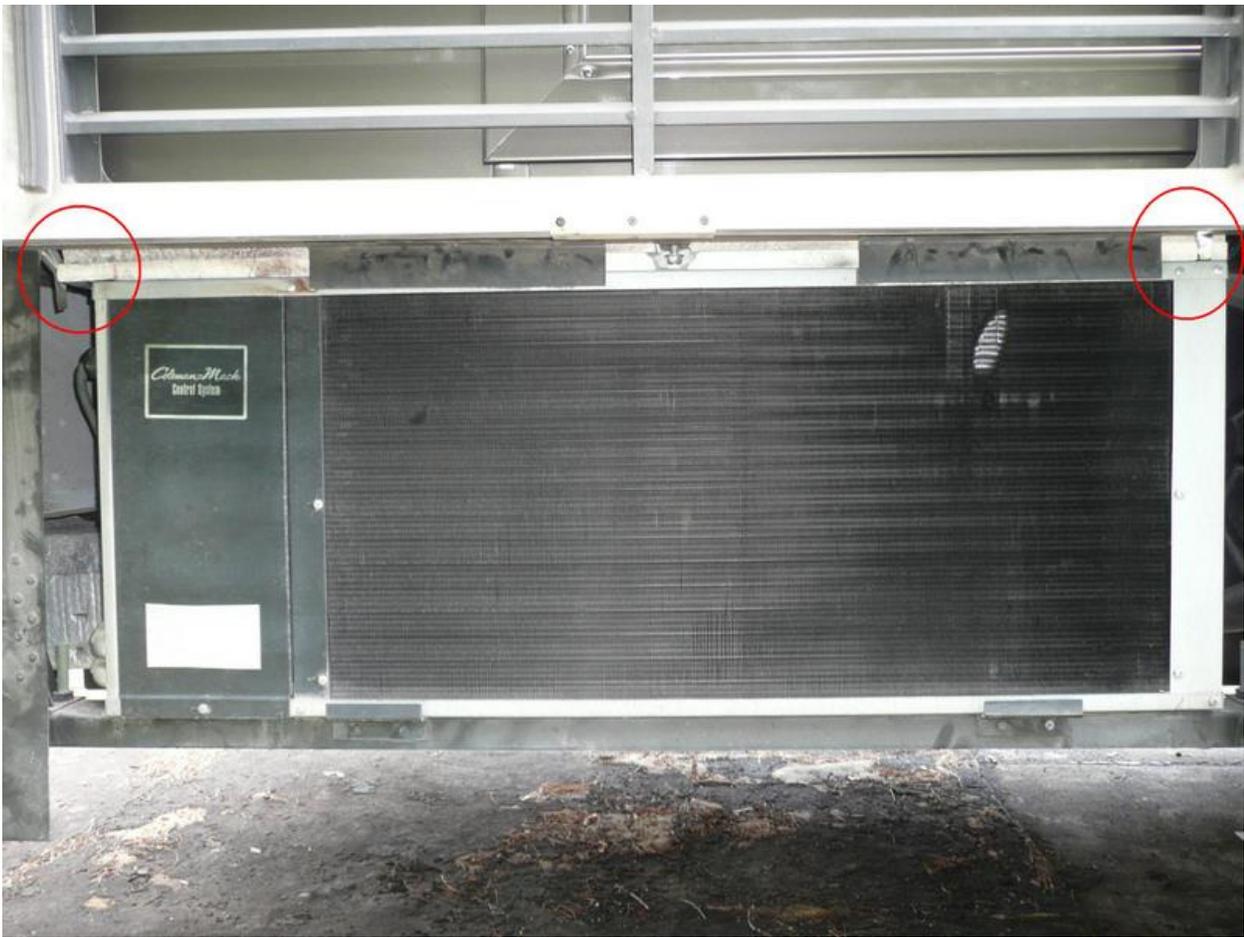
24. Before re-assy, tape up the ends of the two pieces of styrofoam to temporarily hold while the unit is re-inserted.

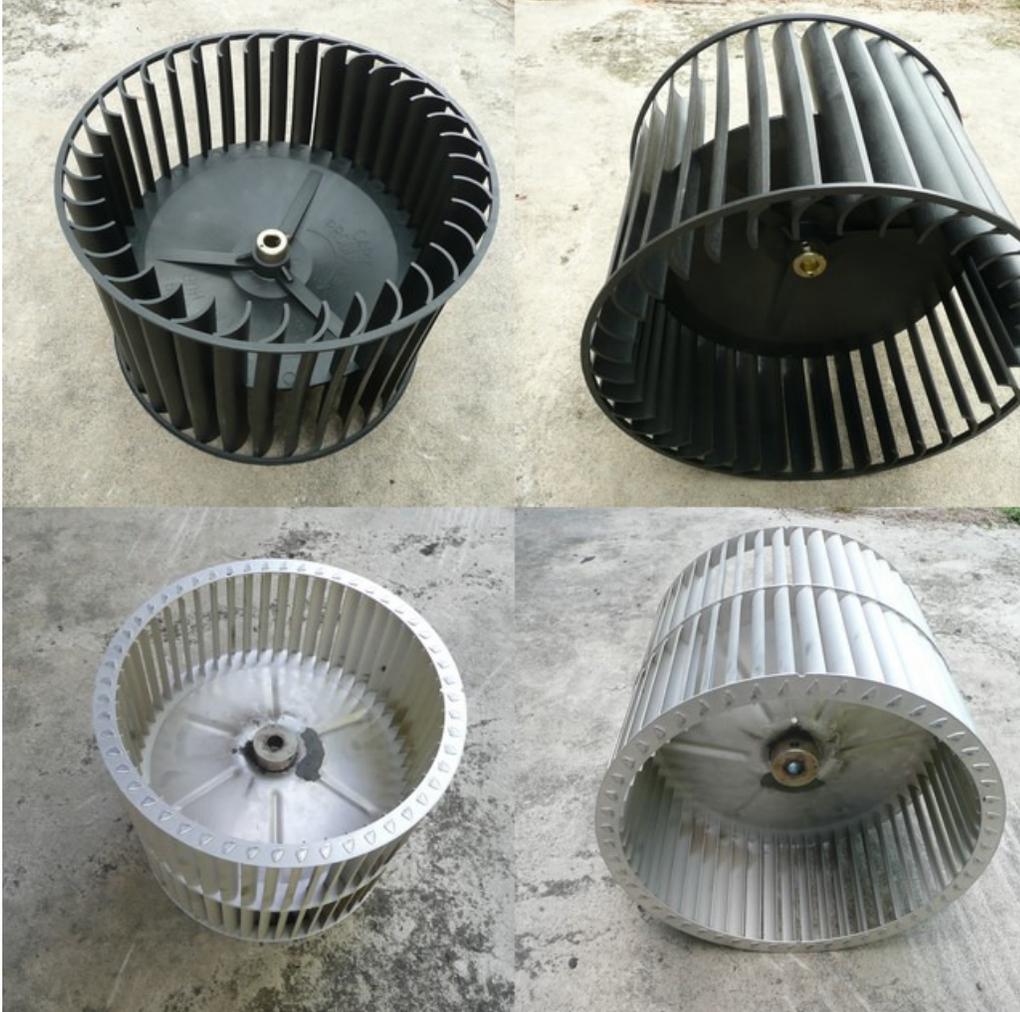
26. New plastic Outdoor Blower is about 1" shorter than the old metal one but the fins are larger. I applied 2-part epoxy (gray glob near hub) over the 2" crack in the center of wheel. The steel insert in the middle of the hub is just pressed on and was loose creating the rattling sound. The failure of the center hub is probably the cause of the re-design to plastic. My theory of the chain of events is the weak press fit at the center loosens, causing wheel wobble, causing the crack in the wheel support, causing the brass bearing to wear out, causing the motor bearings to wear out. The high ambient heat triggered the chain of events in my case. A second theory is the brass bearing wore out first, causing an imbalance, causing a crack, causing a loose hub, causing greater imbalance, causing the motor bearing to wear out.

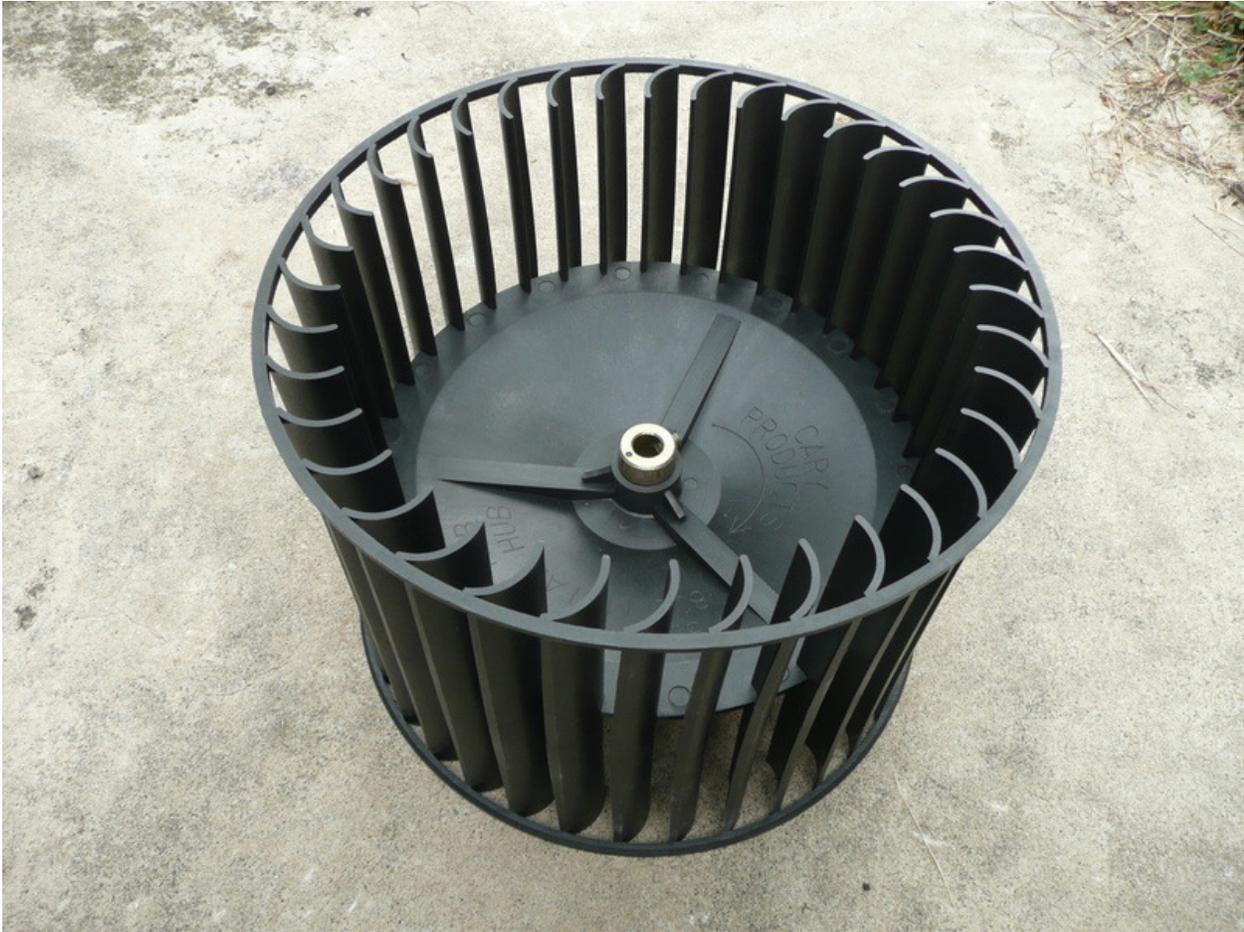
28. The new Outdoor Blower Wheel Package is p/n 1472-1161. Cost is \$47.

27. The new motor p/n 1468a3029 is \$171 purchased on 6/13/08 from RV Products. Sales & service 316-832-4357 in Wichita, KS and ask for Keith in Service (he was very knowledgeable). It was \$18 shipping UPS Ground to Ohio and arrived 3 days later.

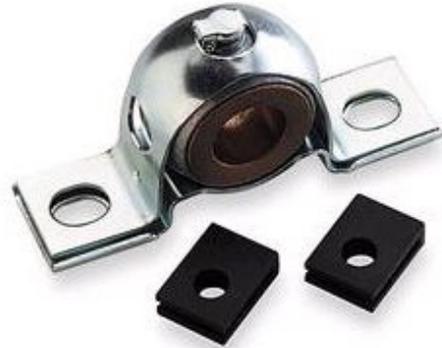
Mounted Bronze Bearing

29. This is the bearing I bought from Graingers. The carrier is somewhat different from the Triangle brand so I just swapped out the metal brackets and used the internal bearing part only. I bought two so I could replace the Indoor Blower bearing at the same time. It was not worn out but it did have 4.5 yrs of service.

Mounted Bronze Bearing, Bore 1/2 in, 2 Bolt Pillow Block , Load Capacity Maximum PV 50000, Self Aligning Type, Pressed Steel Housing

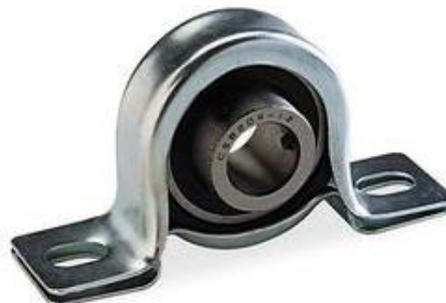
Mounted Ball Bearing

30. If I have to go into the unit again, I will replace the two brass bearings with this sealed ball bearing version and it's only \$4 more.

Mounted Ball Bearing, Bore 1/2 in, 2 Bolt Pressed Steel Housing, Static Load Capacity 1075 Pounds, Dynamic Load Capacity 2152 Pounds, Self Aligning Type
