## CAT C7 FAN BEARING REPLACED WITH GREASE-ABLE BEARING

### BACKGROUND:

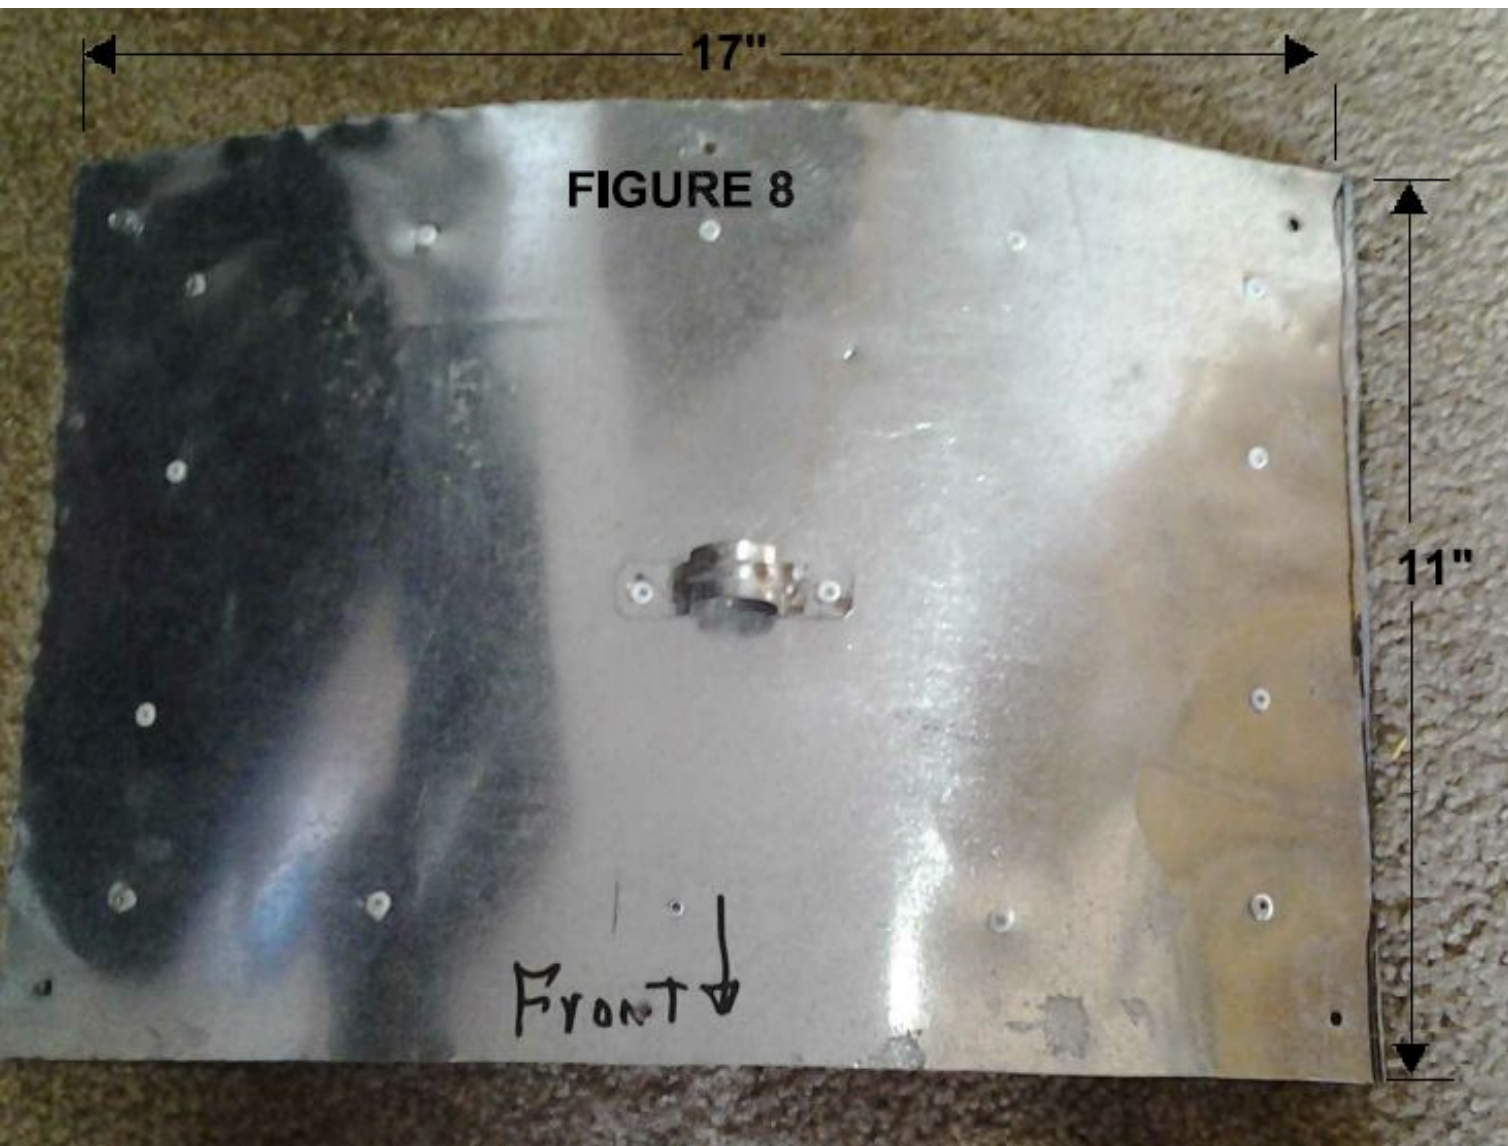
**FIGURE 7**

**FIGURE 5 ACCESS TO FAN:** **Figure 5** shows a metal cover over a cutout of the fan shroud that was made to access the fan and hub bearing. **Figure 6** shows the access to the fan. The fan was removed and moved forward to the inter-cooler. This allowed access to the fan belt and hub bearing. **Figure 7 and 8** shows the cover that was fabricated to cover the hole. The shroud is made of fiberglass and was cut out using an oscillating saw. The cover is made from the fiber glass cutout and sheet metal. The sheet metal is riveted to the fiber glass that was cut out. The cover is attached to the shroud by using six self tapping metal screws.
