LP Refrigerator pilot sensor voltage generator tip pictures.

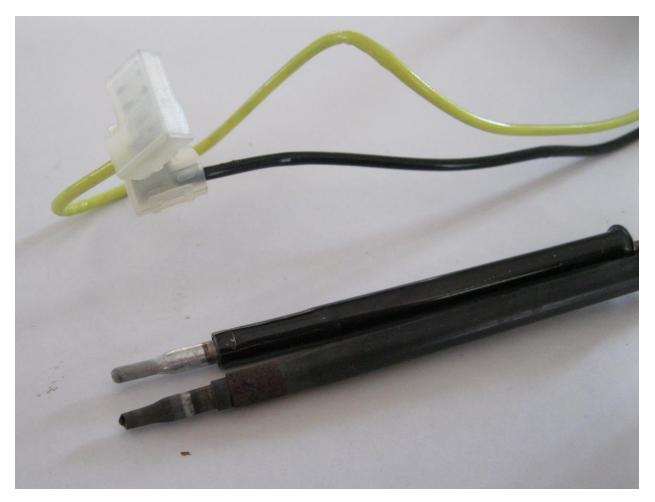
Tip of bottom image has been burned away, sensor can no longer generate the needed voltage.

This voltage is measured in Millie volts. One needs a digital Multimeter that can read this low of a voltage. Voltage needs to be .003 or better. Below this voltage the refrigerator operation will be spotty or totally unusable. No Cooling at all!

The max output from the sensor is around .005. They will last for years, but life time depend on how many hrs. one uses LP.

Replacing the part is not real difficult, but if working around circuit boards and tight spaces is not in everyone's skill set. Get help if you have any second thoughts regarding replacing parts.

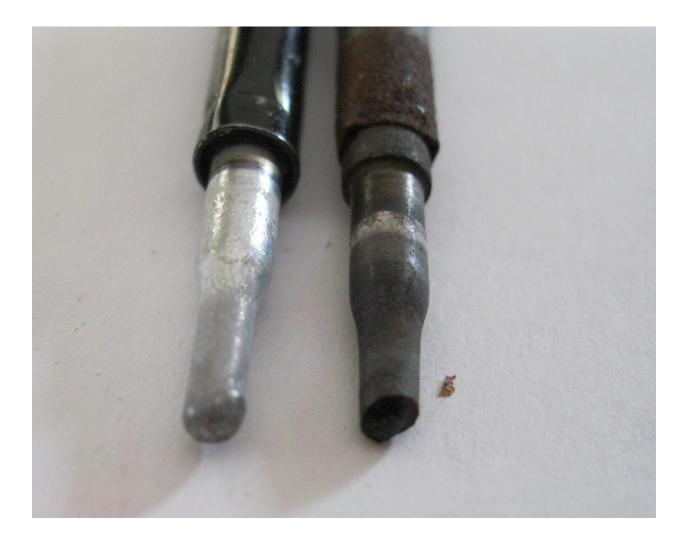
Closeup of a good and defective pilot voltage generator tip.
